**Town of North Yarmouth
Select Board Meeting Agenda
Tuesday, November 7, 2017
6:30PM - Town Office Meeting Room**

Inspection Report

Town of North Yarmouth

**Town of North Yarmouth
Town Hall
Capital Needs Assessment
November 2017**

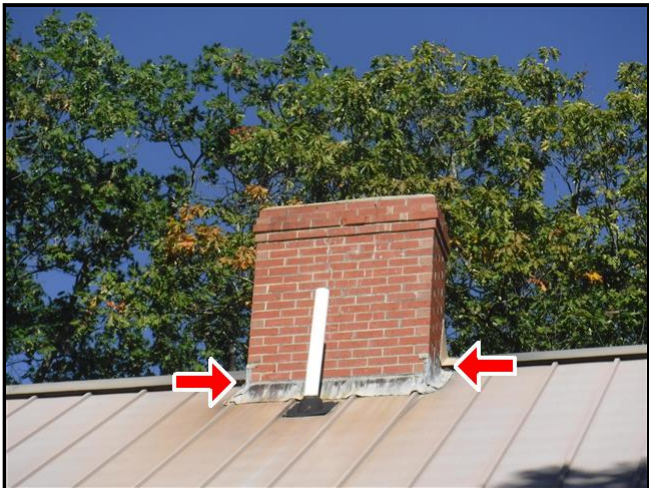
1.2 Item 1(Picture)

1.2 Found water marks around the chimney in the upper storage area ceiling. Have a qualified metal roofing contractor review to install counter flashing to prevent future leaks. Item 1(Picture) Item 2(Picture) Item 3(Picture) Item 4(Picture)

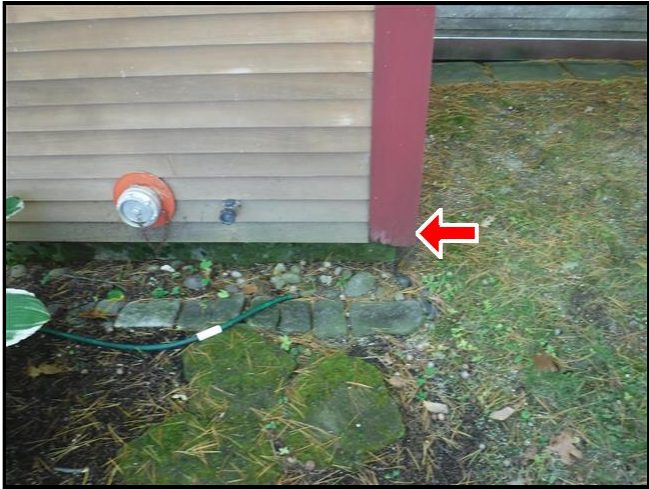
2.0 Item 1(Picture)

Bottom of corner trim rot in need of repairs. Item 1(Picture) Bottom course of siding damaged and in need of repairs. Item 2(Picture)

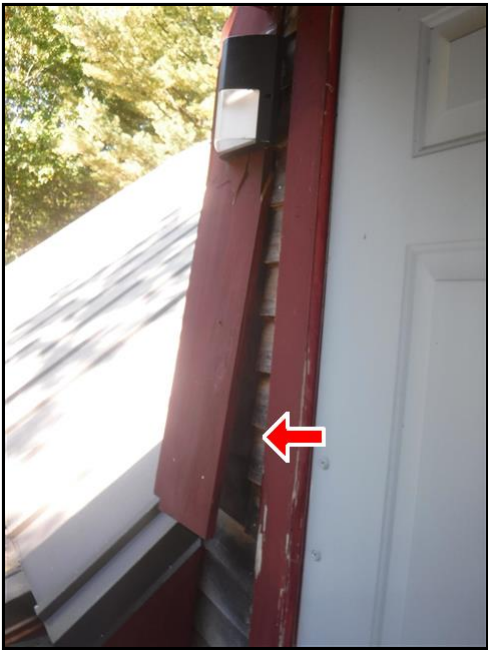
2.0 Item 6(Picture)

Siding and trim repairs and replacement needed on each side of the dormer over the rear upper deck landing. Have a qualified building contractor review to replace all water damaged materials. Item 4(Picture) Item 5(Picture) Item 6(Picture)

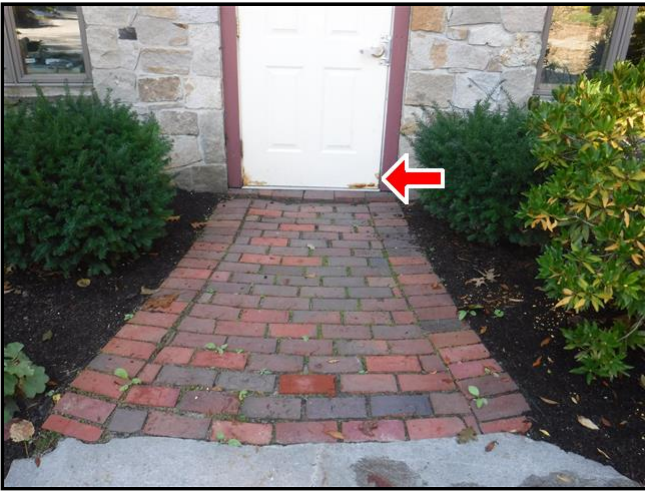
2.1 Item 1(Picture)

2.1 Door rusted and in need of repairs due to water draining down walkway toward the door. Item 1(Picture)

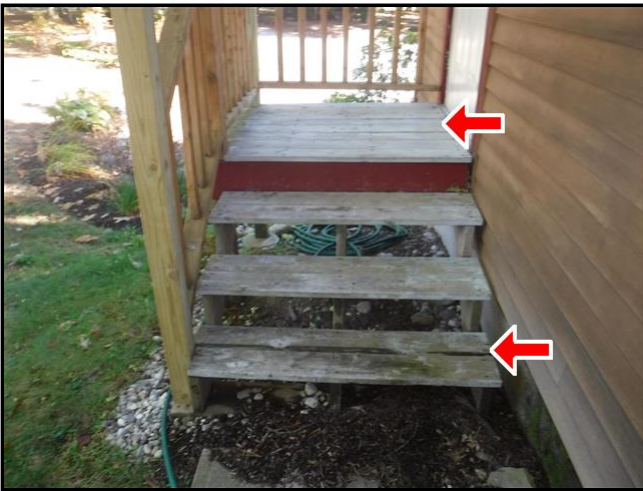
2.3 Item 1(Picture)

2.3 Found the side entry wood porch, steps and rails aged and in need of complete replacement at this time. When replacing install a round graspable handrail. Item 1(Picture) Install the new deck landing one step down from the door threshold to prevent water leaks. Item 2(Picture) Flashing missing, Balusters missing, landing not lag bolted to the building, treads damaged and missing risers. Item 4(Picture) Missing joist hangers. Item 5(Picture) Item 8(Picture)

Recommend having a building contractor review the porch and rear stairs and deck to provide an estimate to replace at this time.

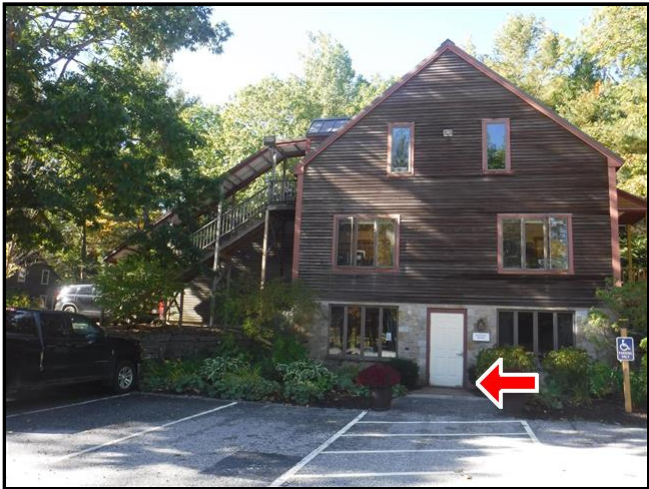
2.4 Item 1(Picture)

2.4 Found the lower level entry door rusted due to the way the walkway is graded. Water drains down walk toward the door and can cause trip/fall hazard with ice buildup in front of the door. Item 1(Picture) Item 2(Picture)

Have a qualified landscaping contractor install the walkway to help drain surface water away from the building and entry door. (door to the meeting room).

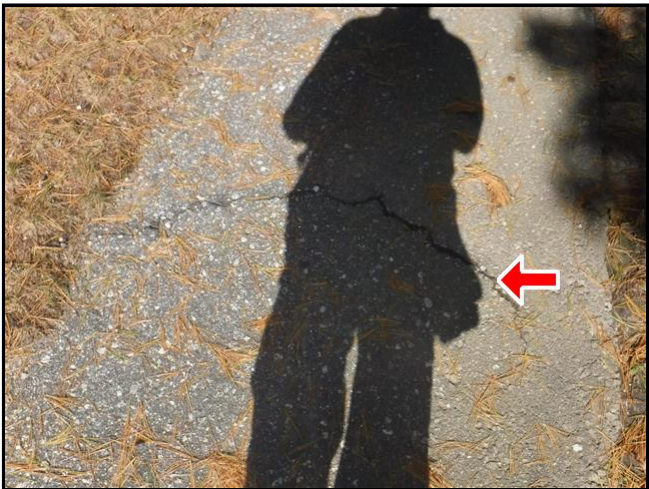
2.4 Item 8(Picture)

Found asphalt walks and areas in the parking in need of repairs to prevent trip/fall hazards. Item 3(Picture) Item 4(Picture) Item 5(Picture) Item 6(Picture) Item 7(Picture) Item 8(Picture)

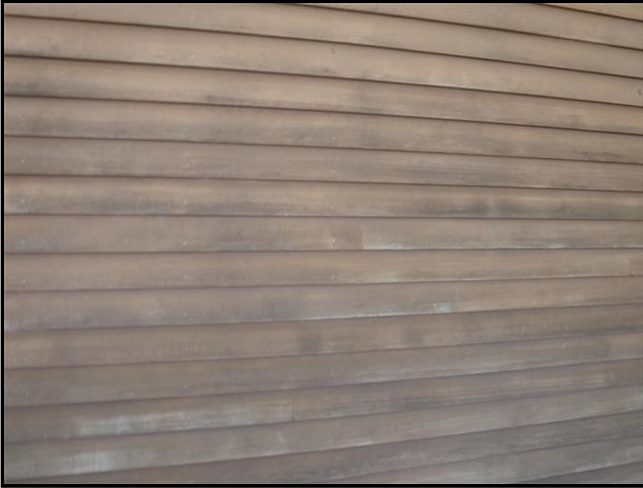
2.6 Item 1(Picture)

2.6 Found the entire exterior siding in need of staining. Exterior trim in need of repainting work at this time.

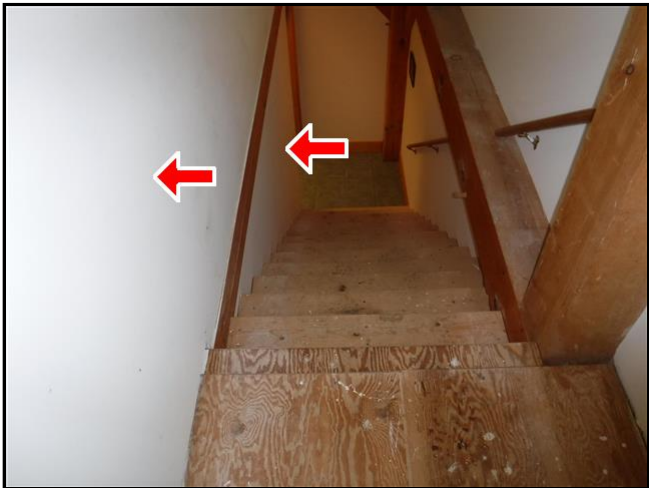
3.3 Item 1(Picture)

3.3 Recommend Installing a continuous Handrail for the cellar stairs. Item 1(Picture) Add a round graspable handrail for added safety. Item 2(Picture)

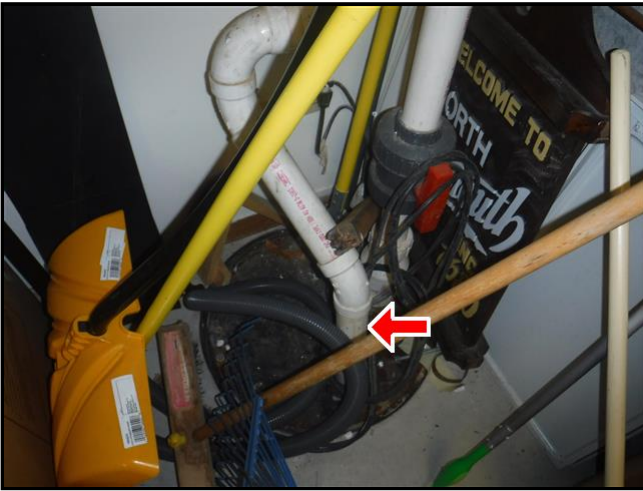
5.0 Item 1(Picture)

5.0 Found the lower level bathrooms need a pump to discharge waste to the main sewer drain. Recommend having a high level alarm installed to alert if the pump malfunctions before waste backs out of the lower plumbing fixtures. Item 1(Picture)

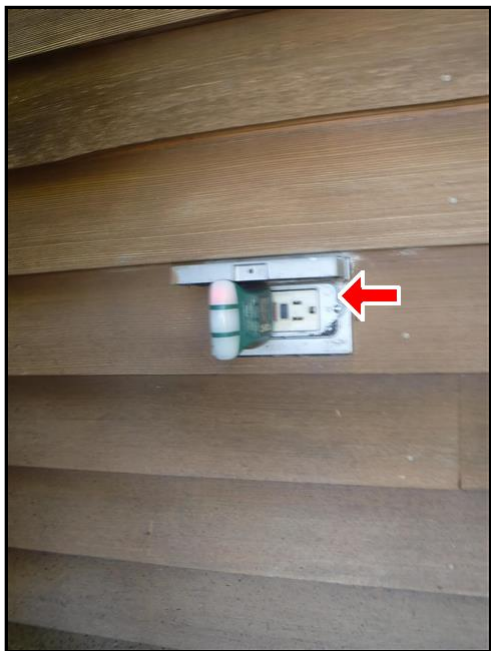
6.4 Item 1(Picture)

6.4 Found the GFCI outside malfunctioned and in need of replacement at this time with a new weather proof cover. Item 1(Picture)

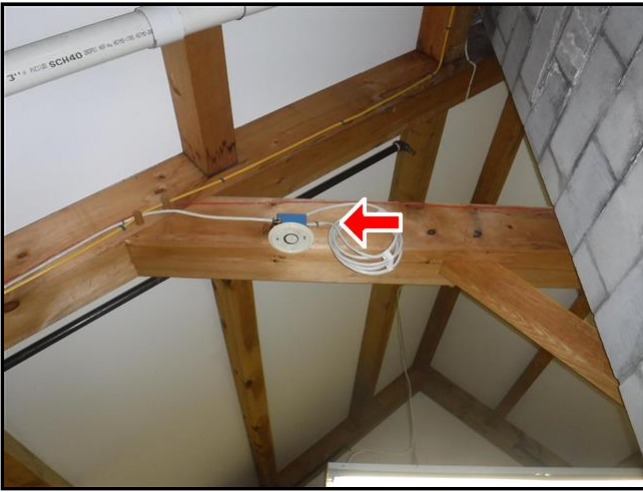
6.6 Item 1(Picture)

6.6 Found the smoke detector in the upper storage area missing at this time. Item 1(Picture)

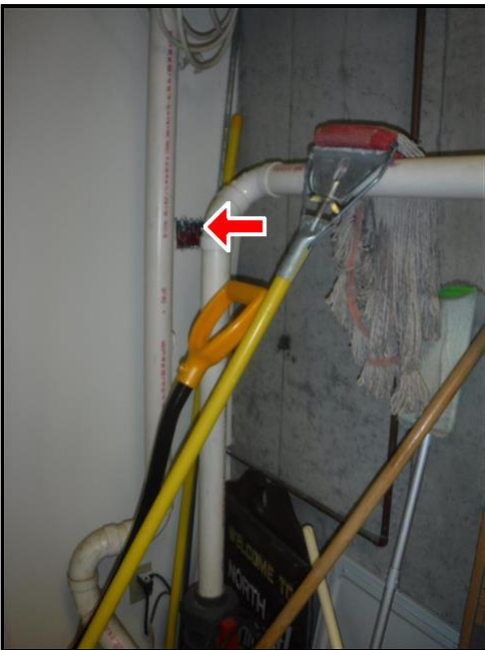
6.8 Found electrical box in need of a cover. Item 1(Picture)

6.8 Item 1(Picture) above sewer pump in basement.

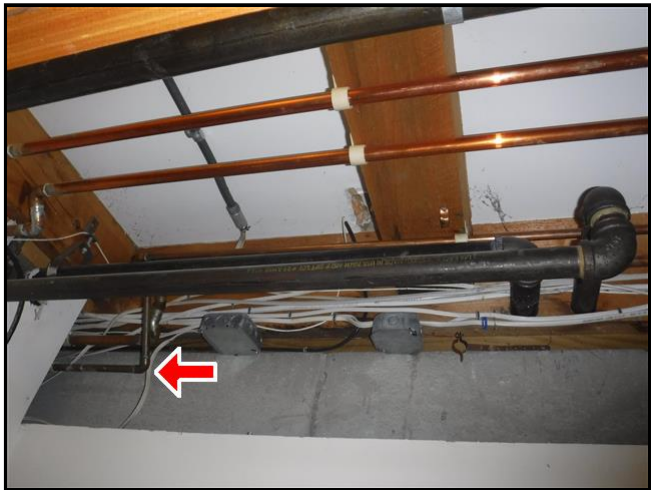
6.9 Item 4(Picture)

6.9 Loose ends of conductors found that should be safely secured by an electrician. Item 1(Picture) Item 2(Picture) Item 3(Picture) Item 4(Picture)

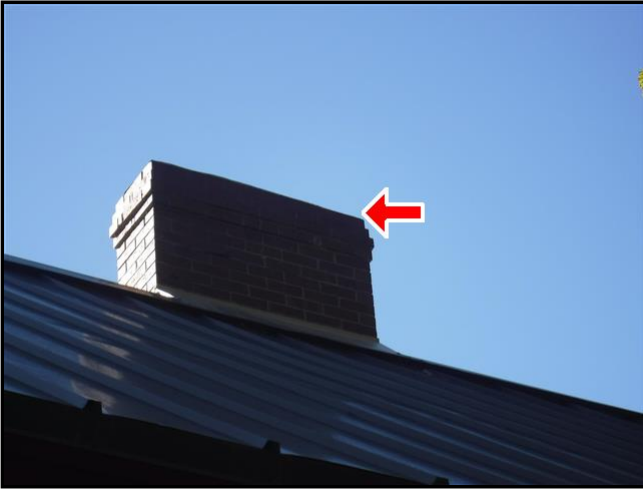
7.6 Item 1(Picture)

Found mortar missing and top of chimney in need of a full coverage rain cap. Item 1(Picture) Item 2(Picture)

7.6 Recommend having a chimney repair contractor review and repair the chimney.

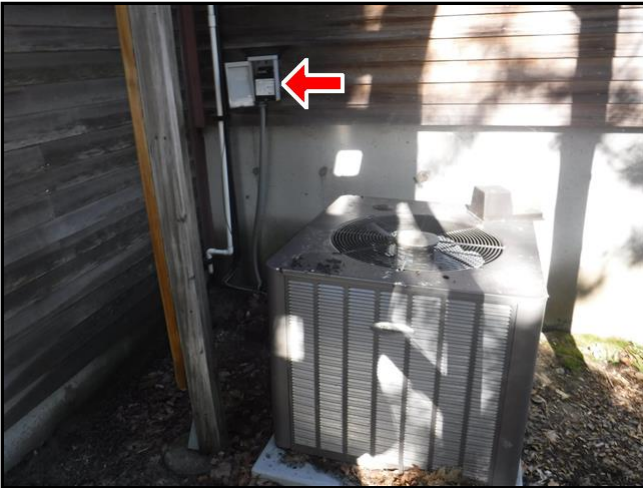
7.9 Item 1(Picture)

7.9 Found the main shut off breaker cover open to the elements outside by the cooler compressor. Keep closed to prevent water damage. Item 1(Picture)

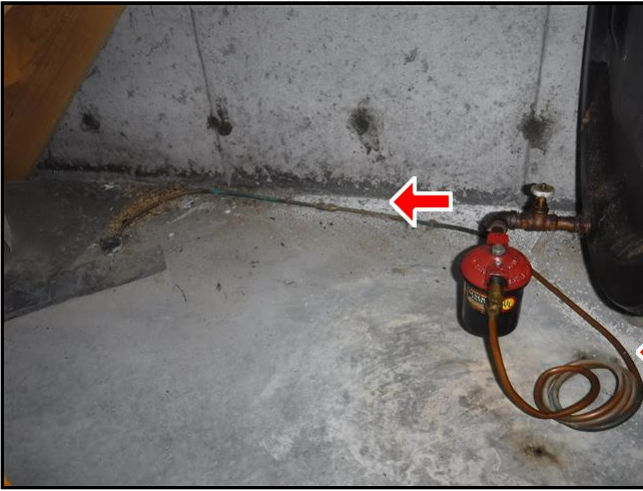
7.12 Item 1(Picture)

Tanks should not be built in to a concealed space to access for service. Have the entire fuel line installed in a protective conduit to prevent damage and corrosion. Item 1(Picture)

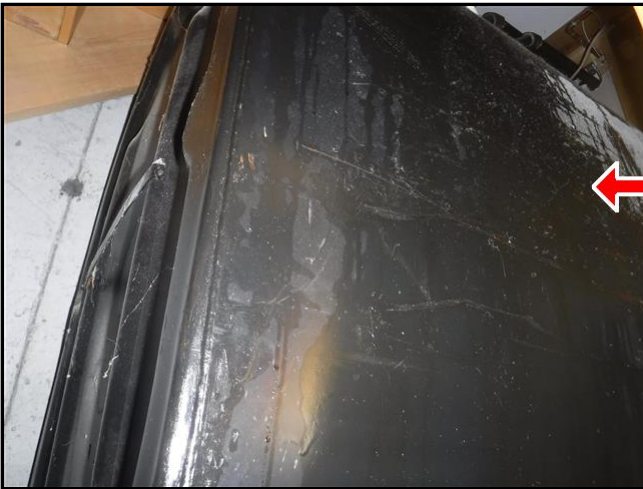
7.12 Item 3(Picture)

7.12 Found oil on the tank that may leak during filling. Leaks appear to be coming from the fill pipe. Item 2(Picture) Item 3(Picture)
