June 2, 2014

SEPTIC SYSTEM INSPECTION NORTH YARMOUTH MEMORIAL SCHOOL

Septic System Inspection

North Yarmouth
Memorial School

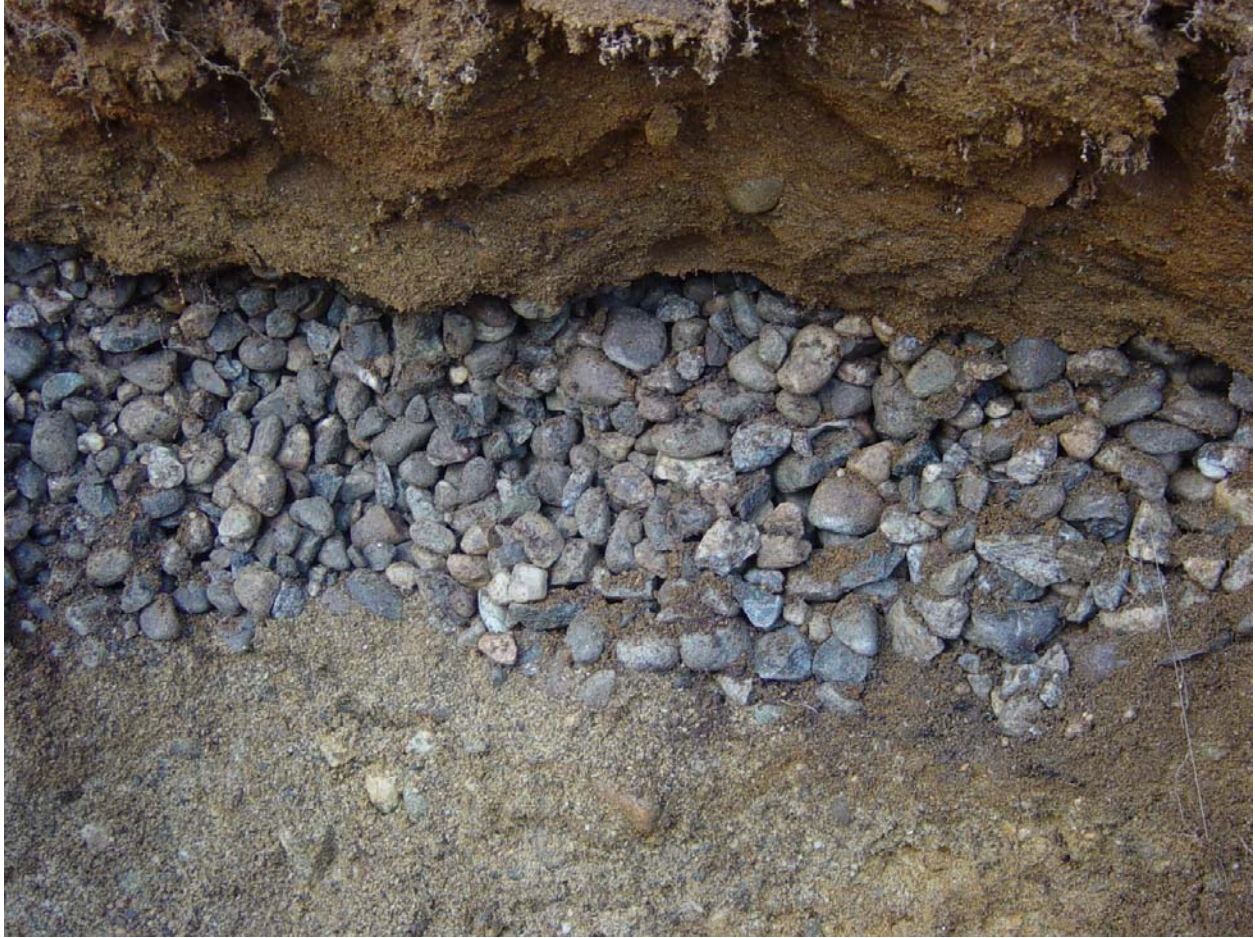
The test pits dug into the edge of the beds revealed 14 inches of loam overlying sand above the top of the stone. The stone was 8 to 12 inches thick and the perforated pipe in the bed was located in the upper portion of the stone. No water was found in any of the 8 test pits and no black sulfide was found to be coating the stone. It is not likely that effluent has ever covered the full bottom on any of the 4 beds.

TEST PIT INTO THE DISPOSAL FIELD SHOWING A CROSS SECTION OF THE STONE
AND OVERLYING SAND

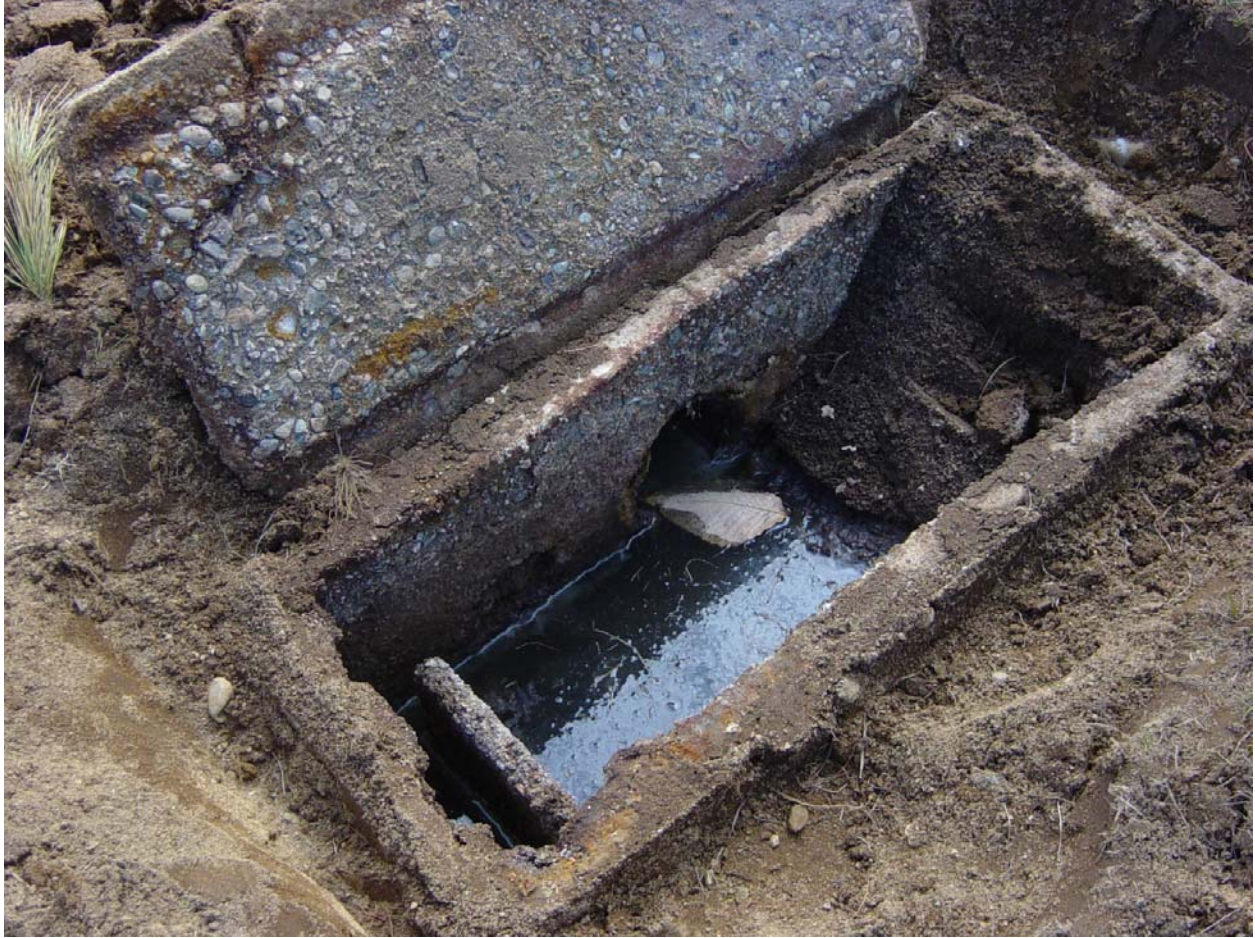
The covers were removed from both distribution boxes. The box closest to the dosing tank was found to be 75 percent full of sand. The sand was plugging the inlet pipe and both 6 inch diameter PVC outlet pipes. No water was found in the box. There was no way to determine how long the pipes have been plugged, but it has likely been years. It is clear that at least one of the siphons in the the dosing chamber is not working. The distribution box closest to Route 9 is receiving all the water from the school. This box is approximately 33 percent filled with sand. The source of the sand in the two distribution boxes is unknown at this time. Both boxes including the covers show corrosion of the concrete and both boxes should be replaced.

Both distribution boxes are cracked and corroded and should be replaced if continued use of the system is planned.

DISTRIBUTION BOX 2 (NEAREST ROUTE 9)
THIS IS THE ONLY BOX RECEIVING EFFLUENT
NOTE THE SAND IN THE BOX

The existing disposal fields can be assumed to have a capacity of 10,000 gallons per day. If continued use is planned, the distribution boxes should be replaced, a distribution box or duplex pump station should replace the siphon pumps, and risers should be added to the septic tank, so all three covers are accessible.

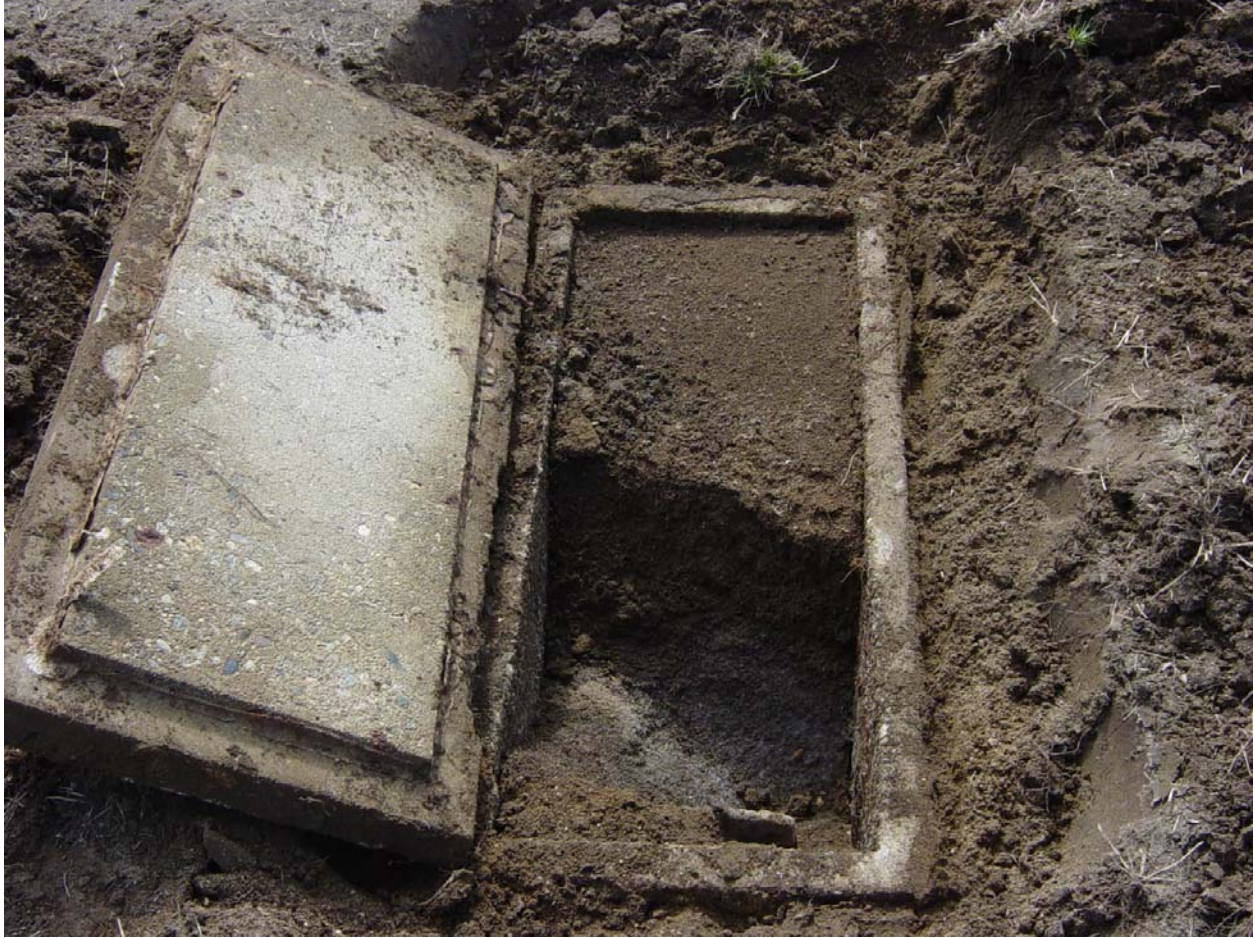
DISTRIBUTION BOX 1 (CLOSEST TO DOSING TANK)
NOTE SAND IN BOX

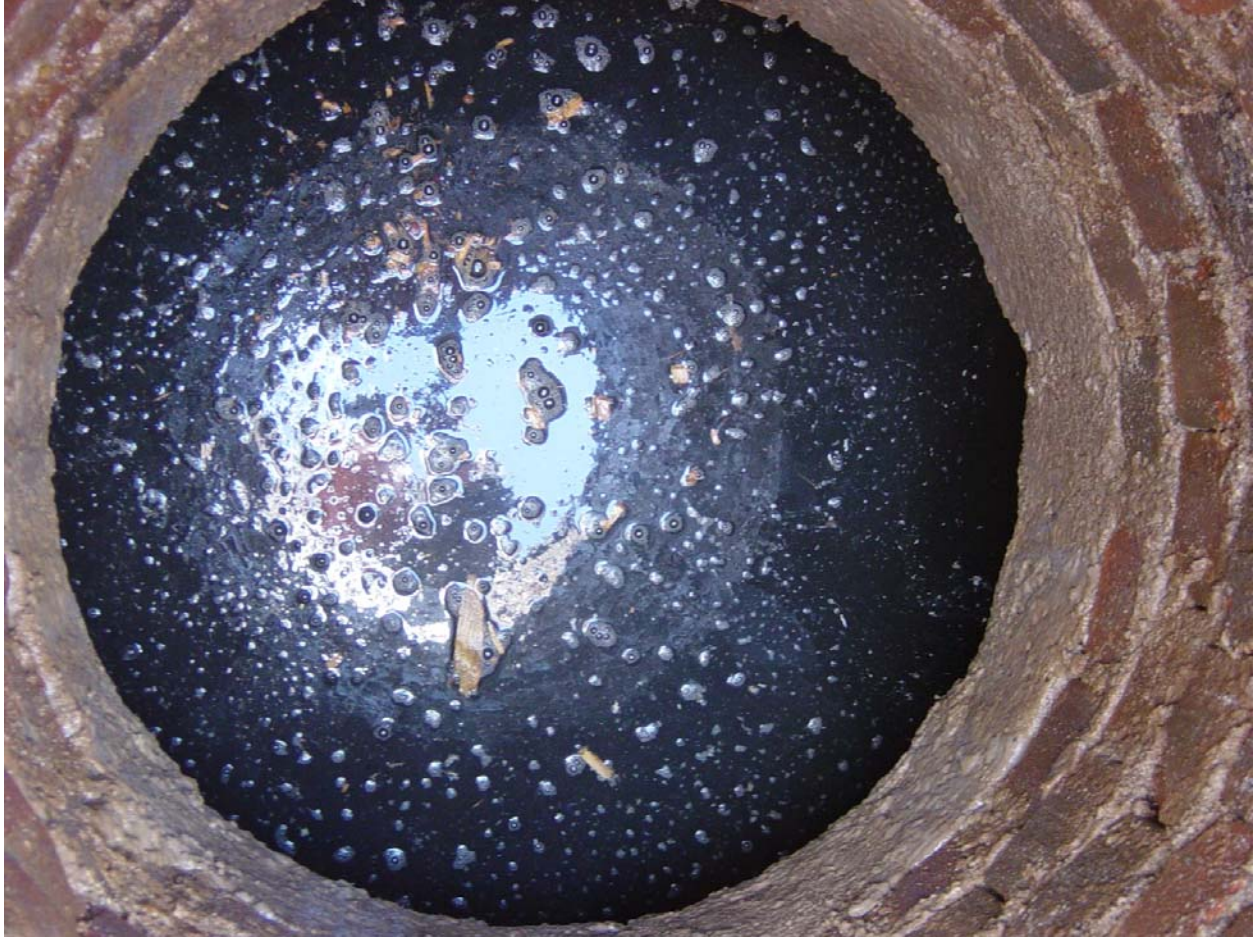
- According to the original septic system design, a dual siphon pump is located in a 400 gallon concrete dosing tank several feet beyond the septic tank. The dosing tank was found and is shown located on the attached site plan.
- A bricked riser and cover similar to the riser found on the septic tank is located over the access cover to the dosing tank.

Access into the siphon tank is similar to the septic tank. The water level in the siphon tank is 3 to 4 inches deep. The pump mechanism was not observed due to the narrow riser opening.

DOSING TANK RISER

The alternating siphon pump is not working correctly and should be replaced by either a distribution box to distribute the effluent equally to the two distribution boxes or a duplex pump station should be installed to alternately pump to both distribution boxes.

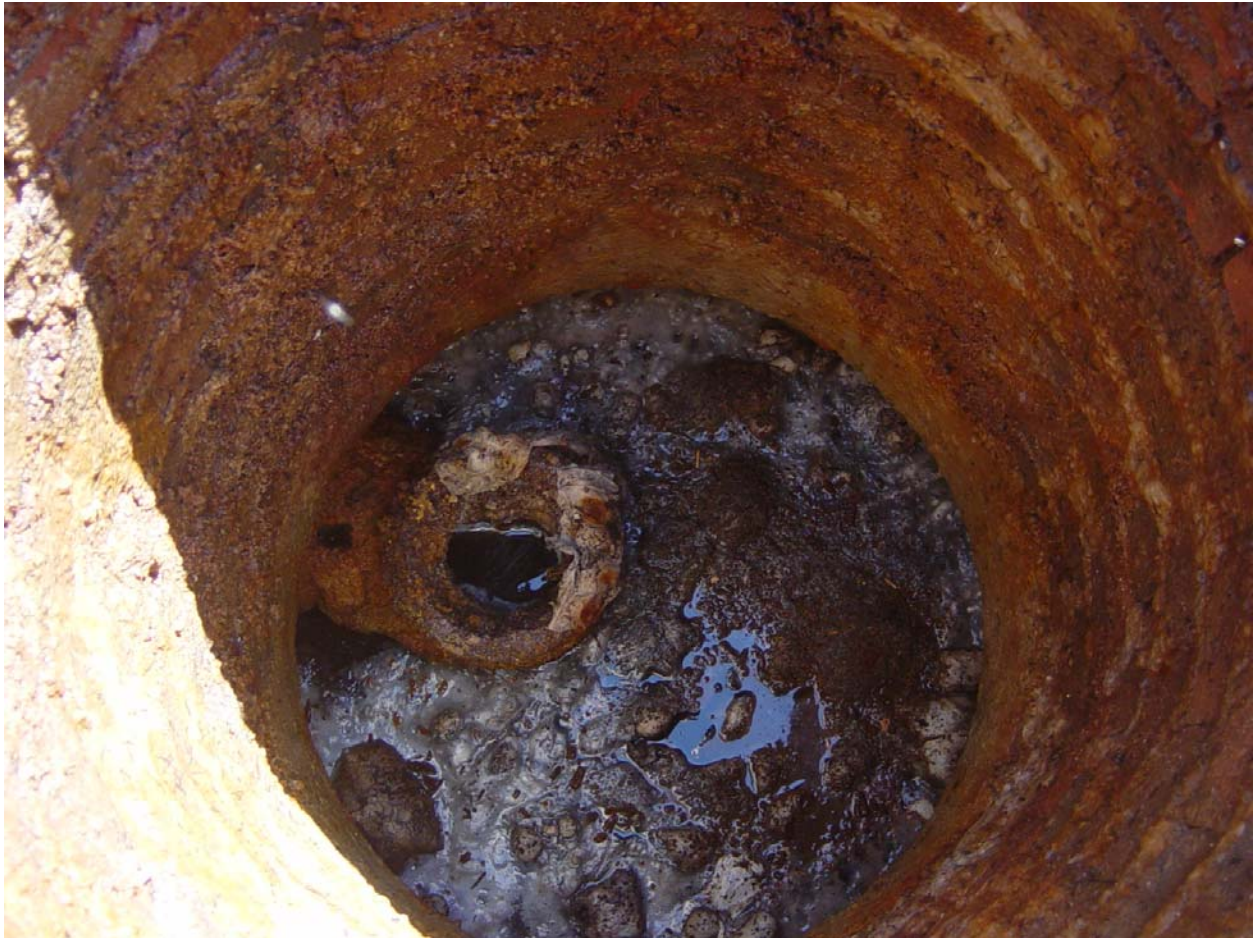
- The septic tank capacity is 10,000 gallons and is located under the wood chip play area, as shown on the attached site plan.
- The top of the tank is 4 feet below the surface and a single riser made of bricks is located over the septic tank outlet cover. The steel cover at the top of the riser is 3 inches below the base of the wood chips.
- Because of the location of the riser and the depth of the tank, it was not possible to determine the sewer line(s) entry point into the tank.

Observation of the septic tank was limited to looking into the brick riser and observing the outlet tee baffle. The riser was in good condition and no cracking was obvious on the top of the tank in the limited area investigated. The floating scum was less than 2 inches thick and did not need to be pumped.

The septic tank is in good condition, but only a small portion of the tank was observed due to the single deep riser over only one of the covers. If continued use of the system is planned,

SEPTIC TANK RISER

two more risers should be installed on the tank to allow complete cleaning of the tank during pumping and to facilitate clearing blockages.
