**Town of North Yarmouth
Select Board Meeting Agenda
Tuesday, November 7, 2017
6:30PM - Town Office Meeting Room**

Inspection Report

Town of North Yarmouth

**Town of North Yarmouth
Town Hall
Capital Needs Assessment
November 2017**

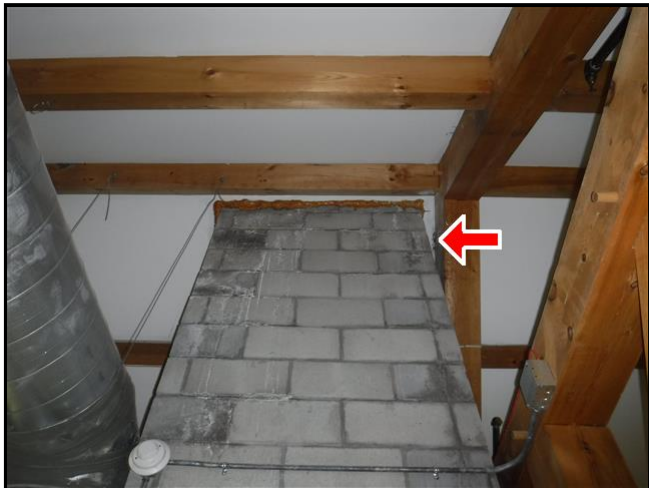
1.2 Item 1(Picture)

1.2 Found water marks around the chimney in the upper storage area ceiling. Have a qualified metal roofing contractor review to install counter flashing to prevent future leaks. Item 1(Picture) Item 2(Picture) Item 3(Picture) Item 4(Picture)

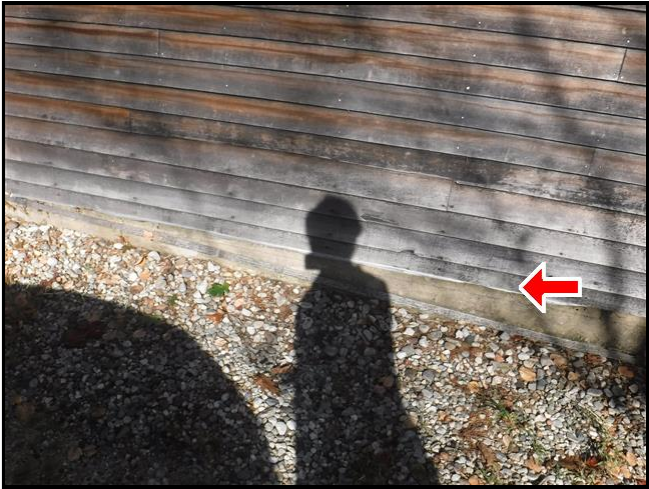
2.0 Item 1(Picture)

Bottom of corner trim rot in need of repairs. Item 1(Picture) Bottom course of siding damaged and in need of repairs. Item 2(Picture)

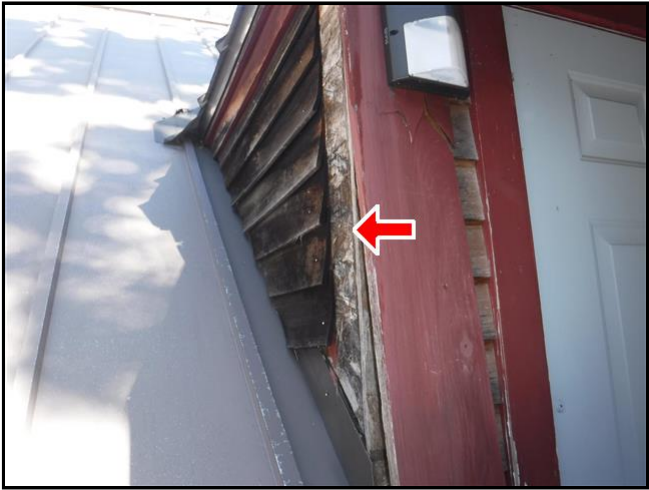
2.0 Item 3(Picture)

2.0 Found siding missing were the rear second floor deck frame is attached to the building. Item 3(Picture)

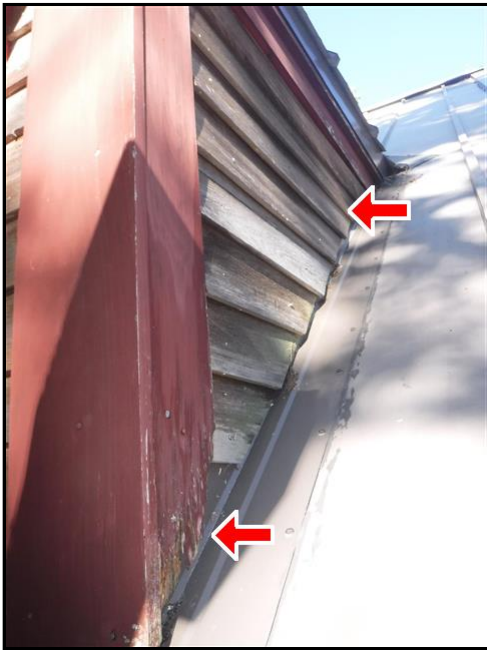
2.0 Item 4(Picture)

Siding and trim repairs and replacement needed on each side of the dormer over the rear upper deck landing. Have a qualified building contractor review to replace all water damaged materials. Item 4(Picture) Item 5(Picture) Item 6(Picture)

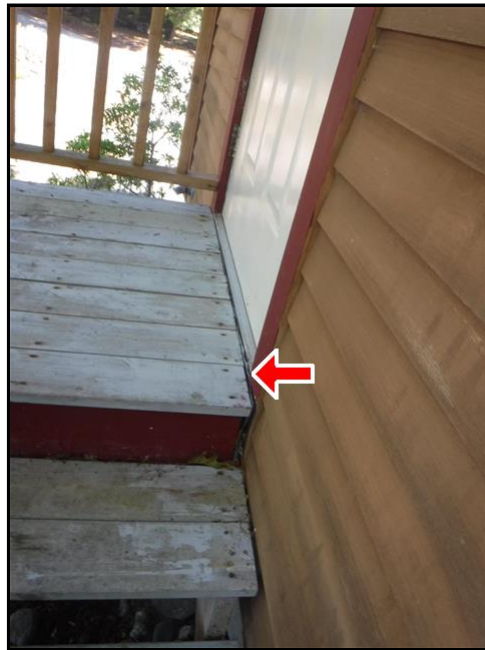
2.3 Item 1(Picture)

2.3 Found the side entry wood porch, steps and rails aged and in need of complete replacement at this time. When replacing install a round graspable handrail. Item 1(Picture) Install the new deck landing one step down from the door threshold to prevent water leaks. Item 2(Picture) Flashing missing, Balusters missing, landing not lag bolted to the building, treads damaged and missing risers. Item 4(Picture) Missing joist hangers. Item 5(Picture) Item 8(Picture)

Recommend having a building contractor review the porch and rear stairs and deck to provide an estimate to replace at this time.

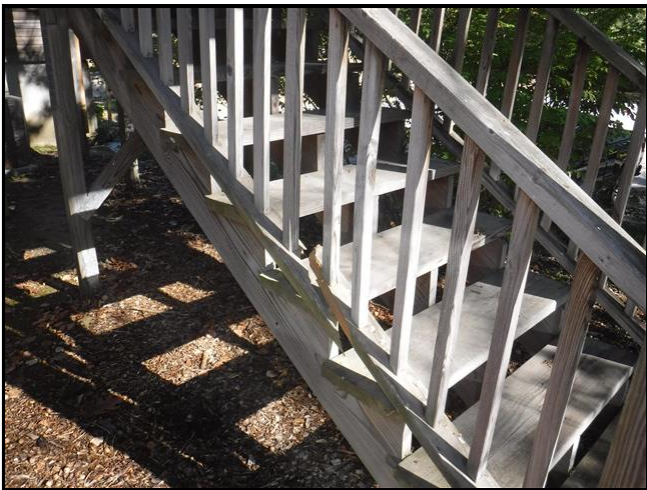
2.3 Item 5(Picture)

The rear second floor deck, steps and railings in need of complete replacement at this time. Found reinforced with metal brackets that do not provide lateral support. Item 6(Picture) Missing risers and round graspable handrail. Item 7(Picture)

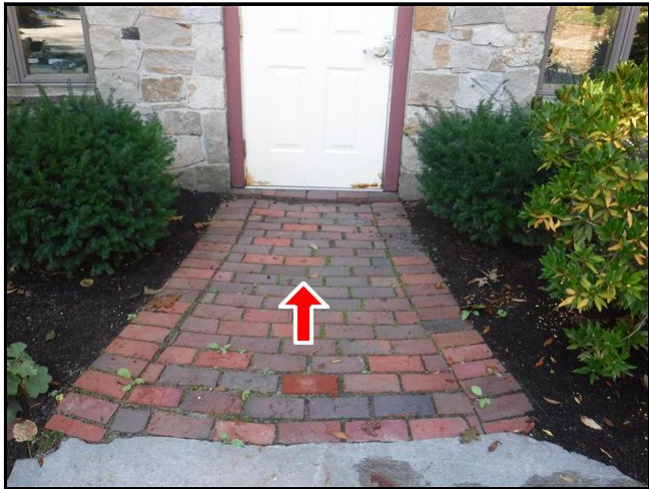
2.4 Item 1(Picture)

2.4 Found the lower level entry door rusted due to the way the walkway is graded. Water drains down walk toward the door and can cause trip/fall hazard with ice buildup in front of the door. Item 1(Picture) Item 2(Picture)

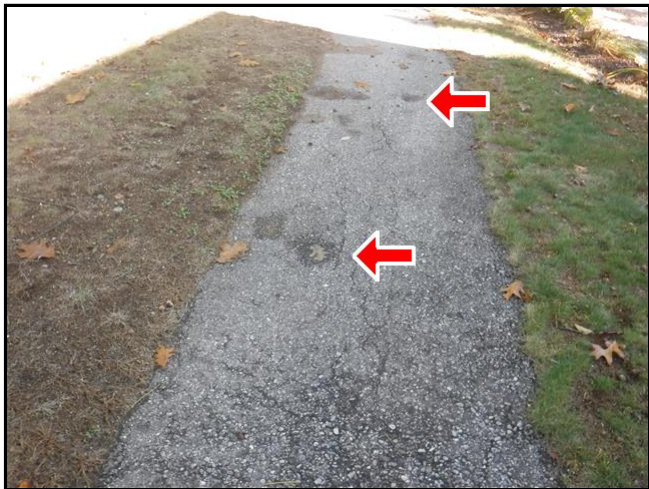
2.4 Item 3(Picture)

Found asphalt walks and areas in the parking in need of repairs to prevent trip/fall hazards. Item 3(Picture) Item 4(Picture) Item 5(Picture) Item 6(Picture) Item 7(Picture) Item 8(Picture)

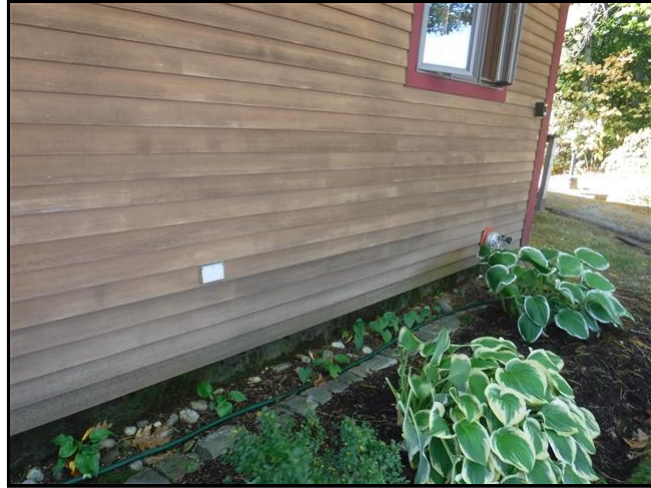
2.6 Item 1(Picture)

2.6 Found the entire exterior siding in need of staining. Exterior trim in need of repainting work at this time.

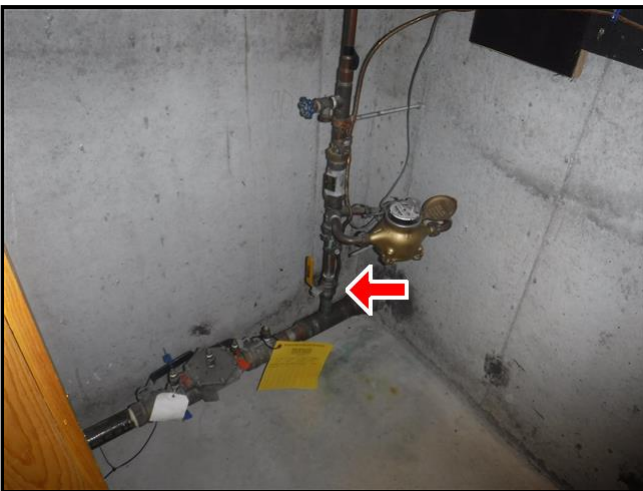
5.3 Item 1(Picture)

5.3 Located in the basement on the main water line by the meter. Item 1(Picture)

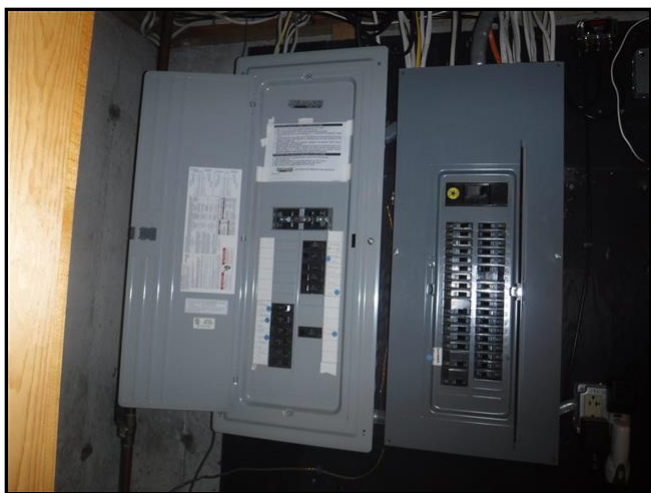
6.5 Item 1(Picture)

6.5 Main panel and generator panel located in the basement.

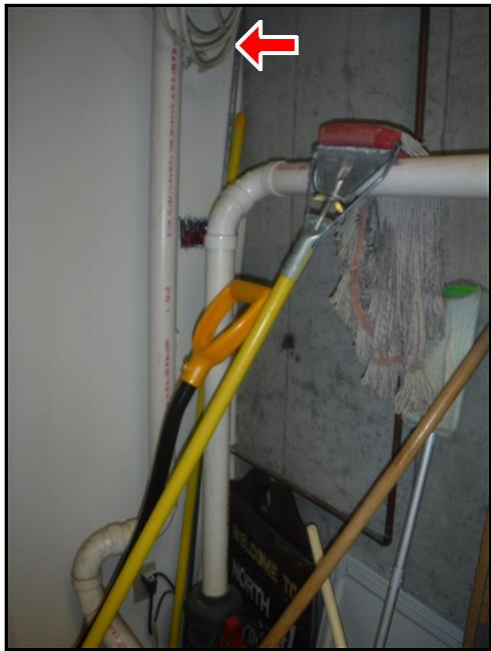
6.9 Loose ends of conductors found that should be safely secured by an electrician. Item 1(Picture) Item 2(Picture) Item 3(Picture) Item 4(Picture)

6.9 Item 1(Picture) above sewer pump in basement

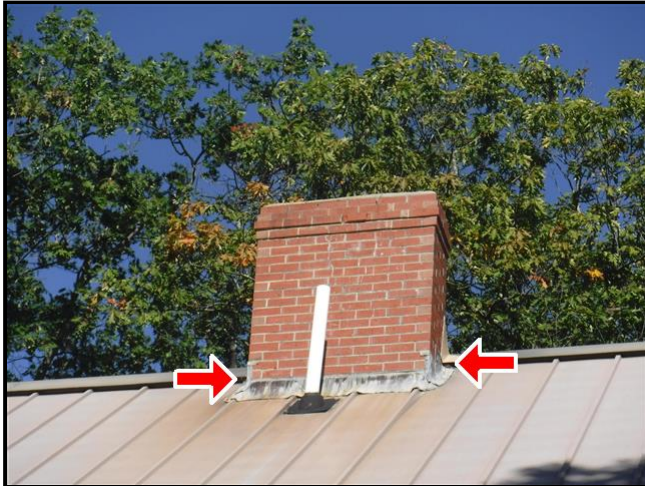
1.2 Item 1(Picture)

Found water marks around the chimney in the upper storage area ceiling. Have a qualified metal roofing contractor review to install counter flashing to prevent future leaks. Item 1(Picture) Item 2(Picture) Item 3(Picture) Item 4(Picture)

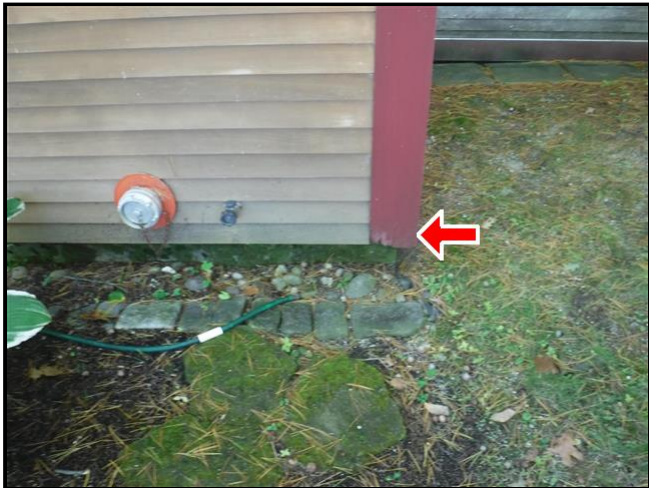
2.0 Item 1(Picture)

Bottom of corner trim rot in need of repairs. Item 1(Picture) Bottom course of siding damaged and in need of repairs. Item 2(Picture)

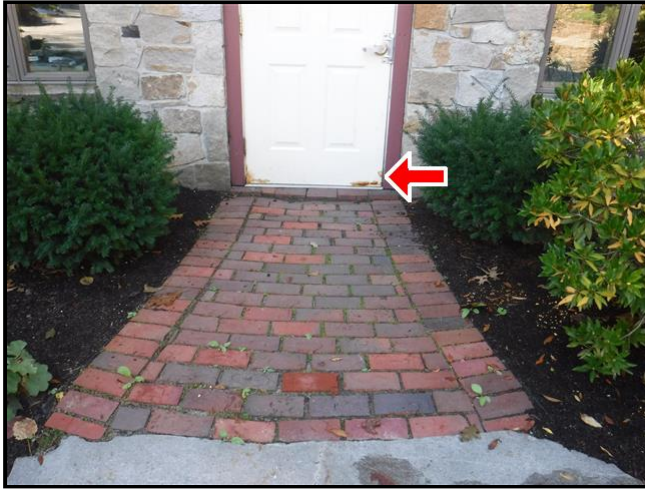
2.1 Item 1(Picture)

Door rusted and in need of repairs due to water draining down walkway toward the door. Item 1(Picture)

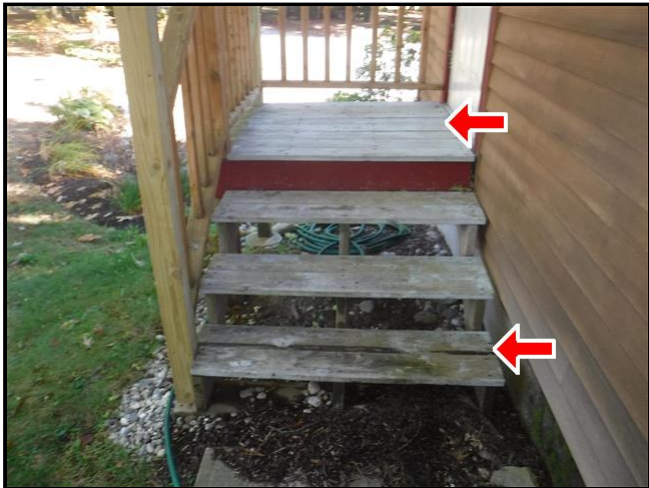
2.3 Item 1(Picture)

Found the side entry wood porch, steps and rails aged and in need of complete replacement at this time. When replacing install a round graspable handrail. Item 1(Picture) Install the new deck landing one step down from the door threshold to prevent water leaks. Item 2(Picture) Flashing missing, Balusters missing, landing not lag bolted to the building, treads damaged and missing risers. Item 4(Picture) Missing joist hangers. Item 5(Picture) Item 8(Picture)

Recommend having a building contractor review the porch and rear stairs and deck to provide an estimate to replace at this time.

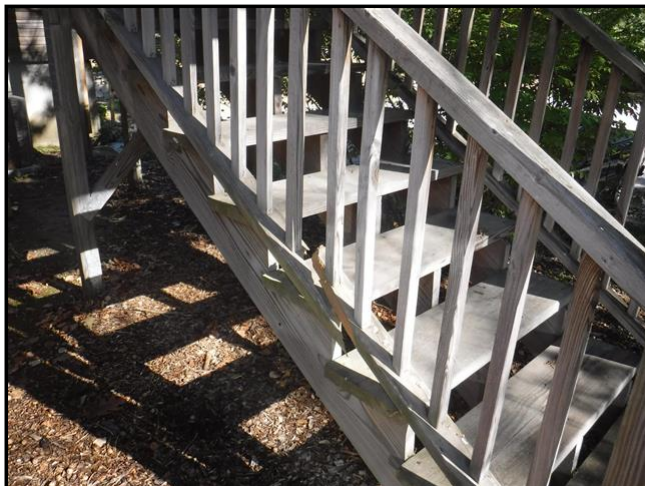
2.3 Item 6(Picture)

The rear second floor deck, steps and railings in need of complete replacement at this time. Found reinforced with metal brackets that do not provide lateral support. Item 6(Picture) Missing risers and round graspable handrail. Item 7(Picture)

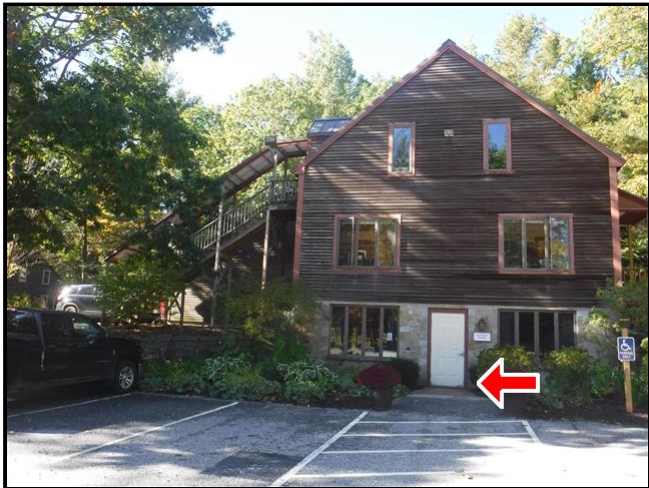
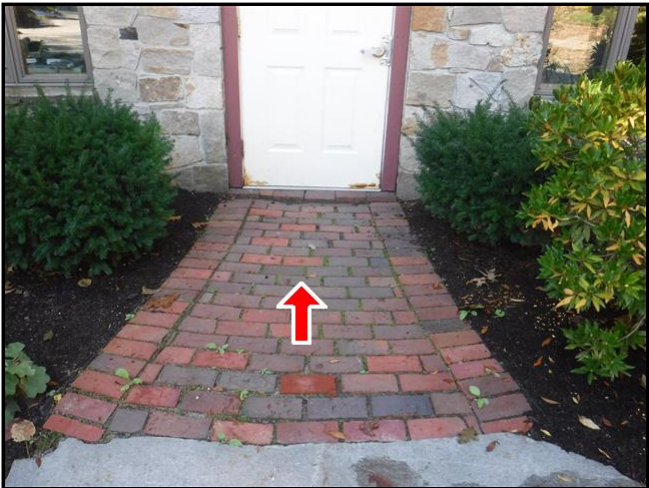
Found the lower level entry door rusted due to the way the walkway is graded. Water drains down walk toward the door and can cause trip/fall hazard with ice buildup in front of the door. Item 1(Picture) Item 2(Picture)

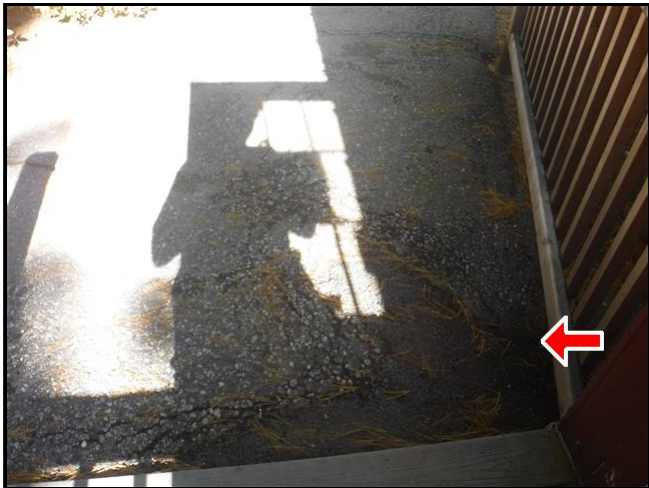
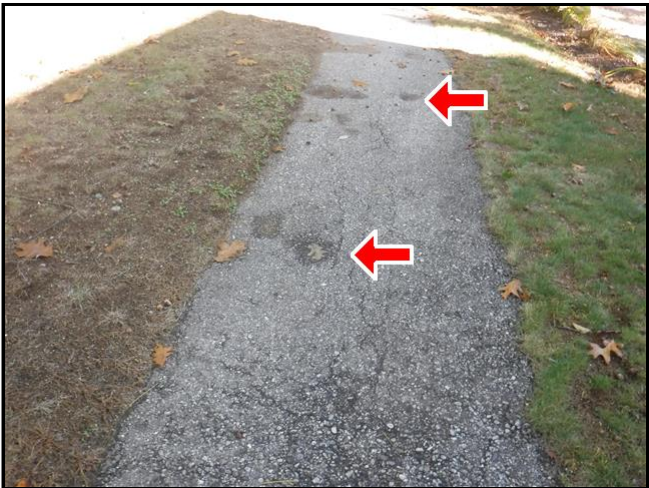
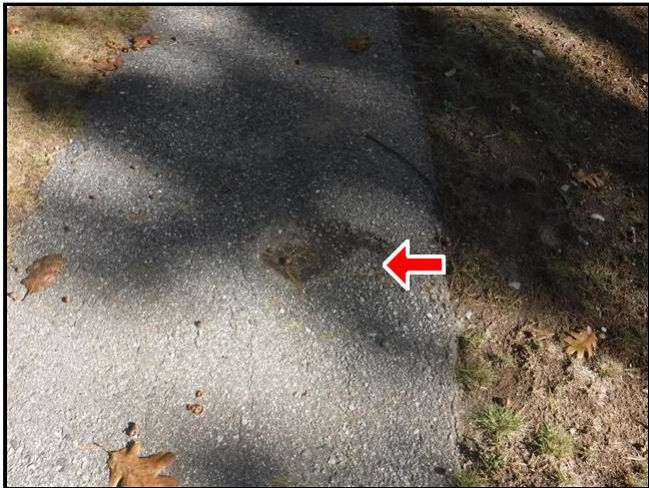
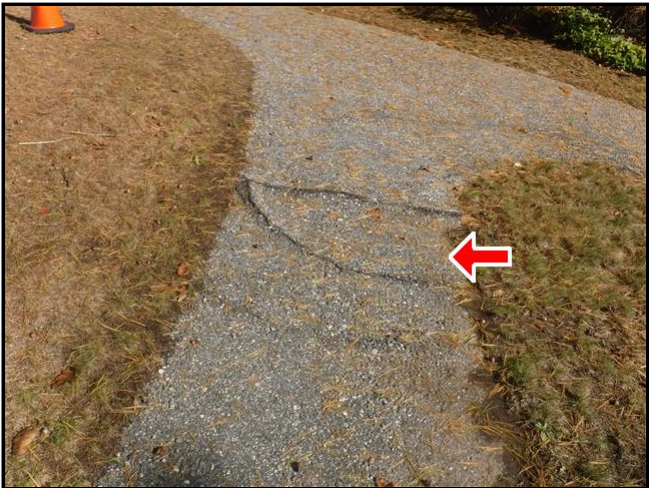
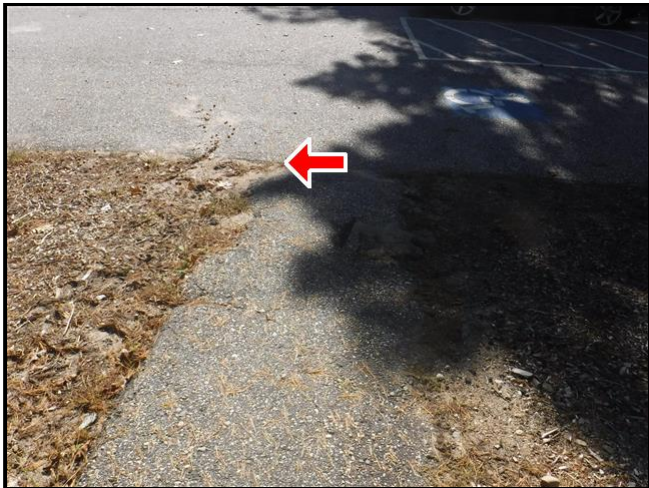
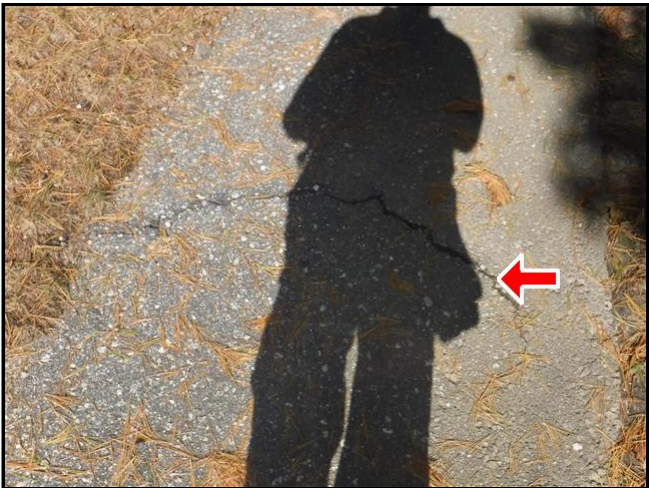
Found asphalt walks and areas in the parking in need of repairs to prevent trip/fall hazards. Item 3(Picture) Item 4(Picture) Item 5(Picture) Item 6(Picture) Item 7(Picture) Item 8(Picture)

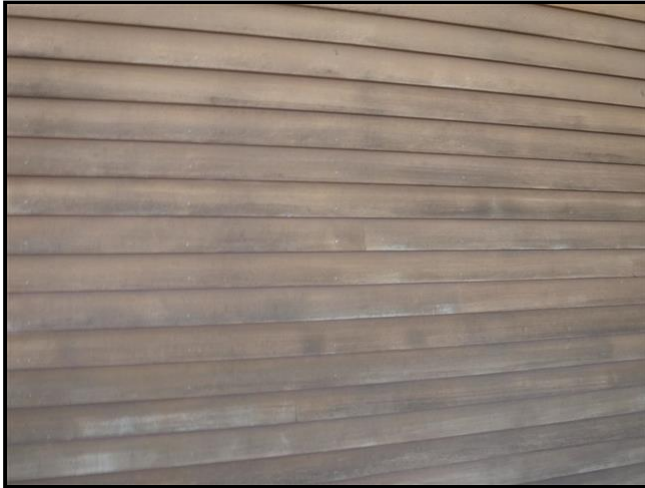
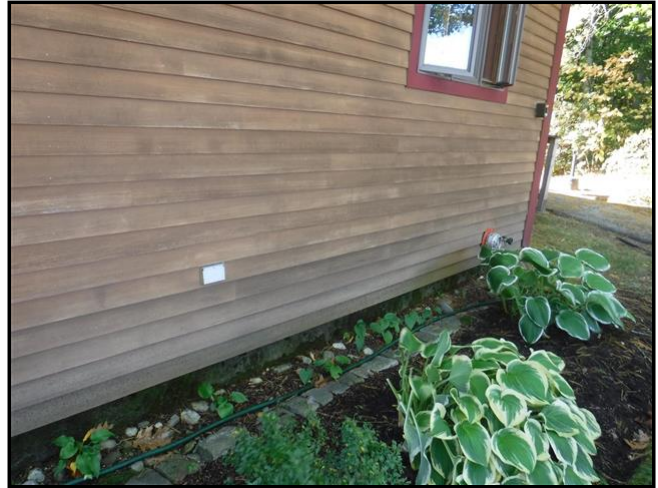
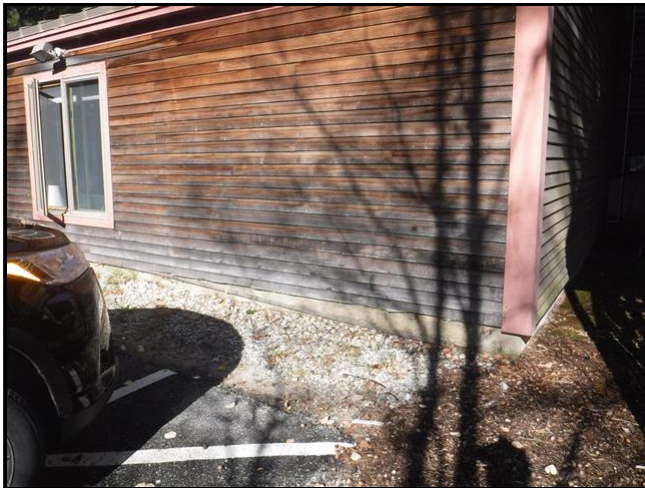
Found the entire exterior siding in need of staining. Exterior trim in need of repainting work at this time. Item 1(Picture) Item 2(Picture) Item 3(Picture)

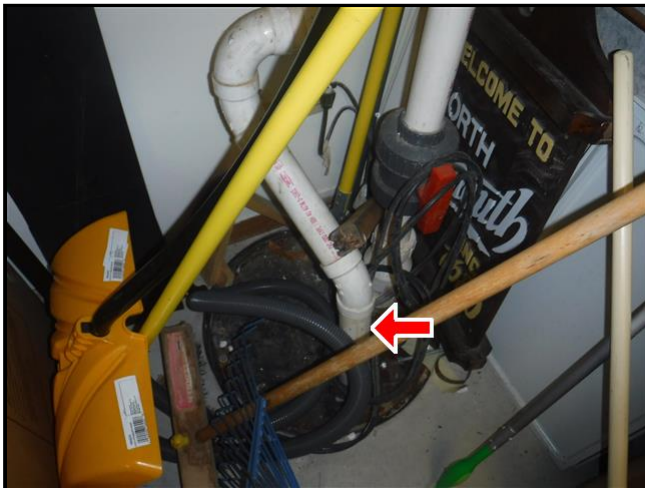
5.0 Item 1(Picture)

Found the lower level bathrooms need a pump to discharge waste to the main sewer drain. Recommend having a high level alarm installed to alert if the pump malfunctions before waste backs out of the lower plumbing fixtures. Item 1(Picture)

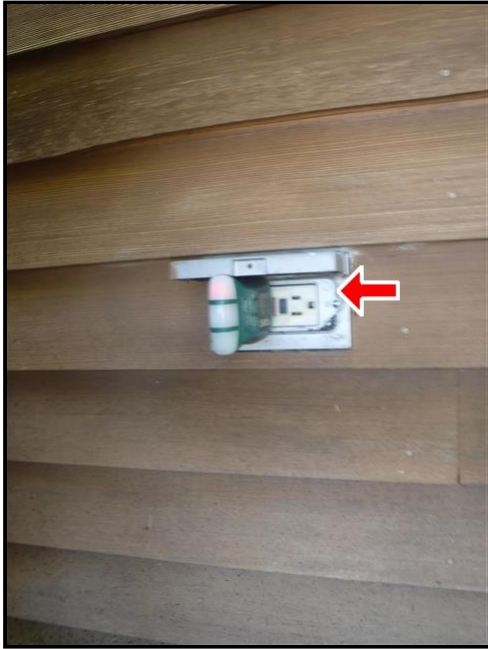
6.4 Item 1(Picture)

Found the GFCI outside malfunctioned and in need of replacement at this time with a new weather proof cover. Item 1(Picture)

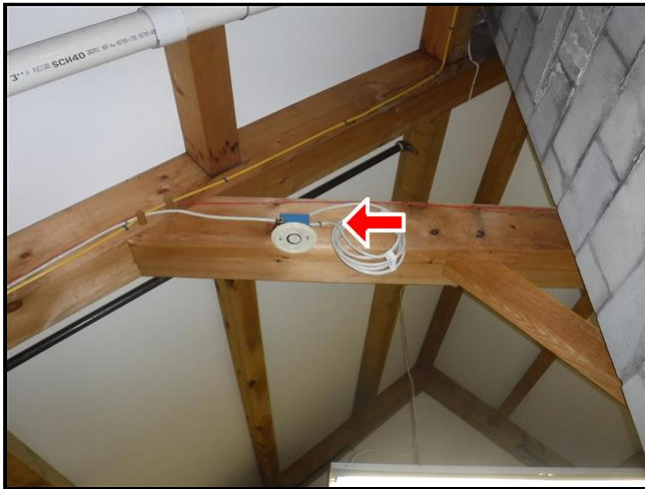
6.6 Item 1(Picture)

Found the smoke detector in the upper storage area missing at this time. Item 1(Picture)

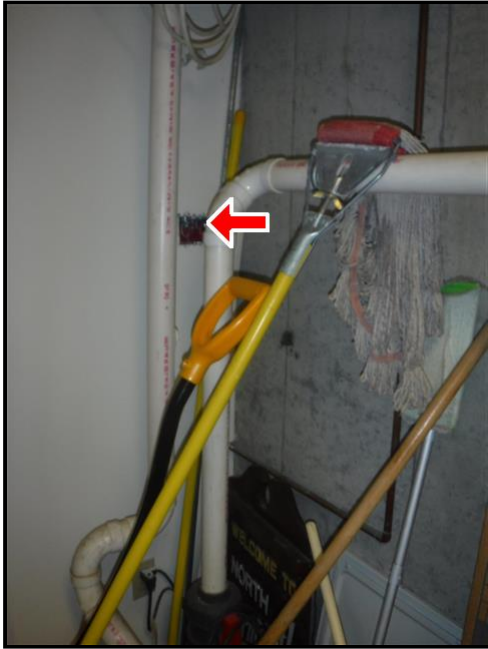
Found electrical box in need of a cover. Item 1(Picture)

6.8 Item 1(Picture) above sewer pump in basement.

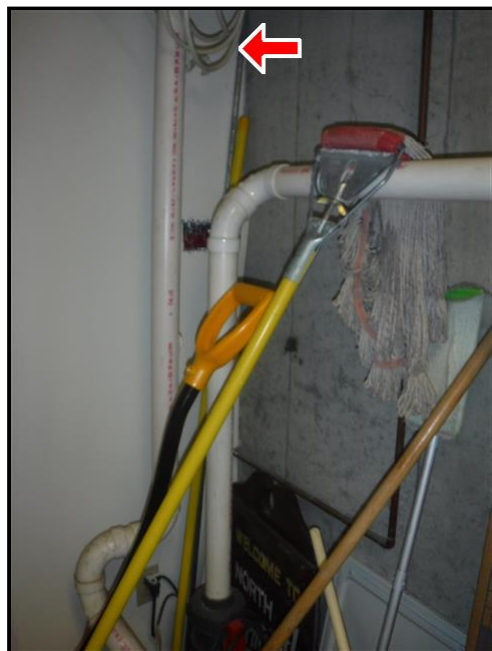
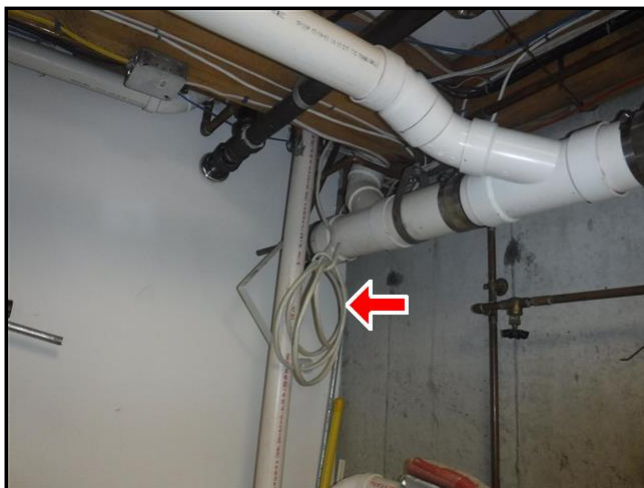
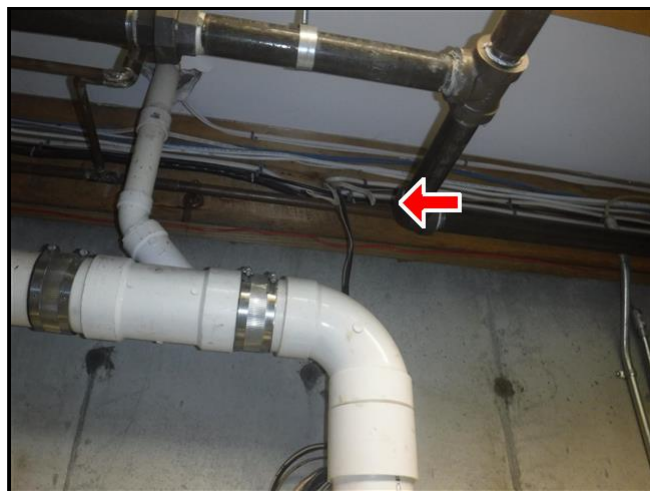
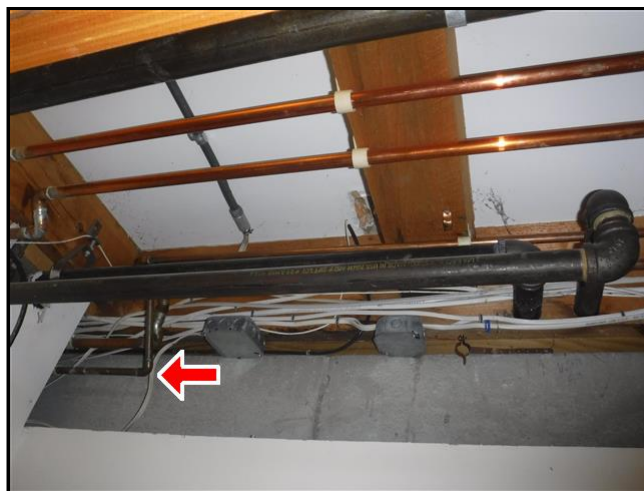
Loose ends of conductors found that should be safely secured by an electrician. Item 1(Picture) Item 2(Picture) Item 3(Picture) Item 4(Picture)

6.9 Item 1(Picture) above sewer pump in basement

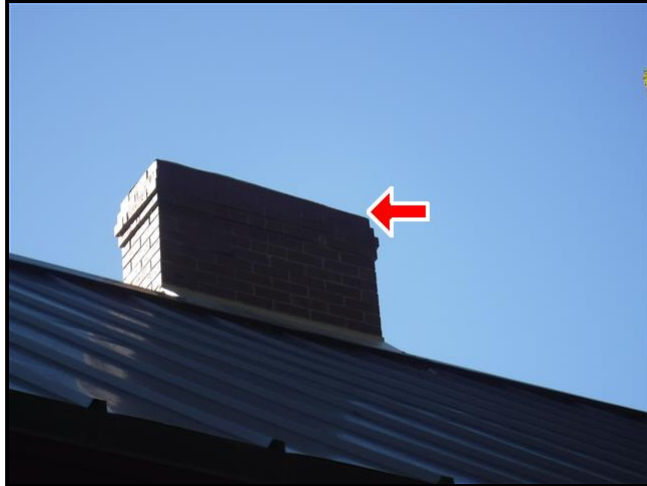
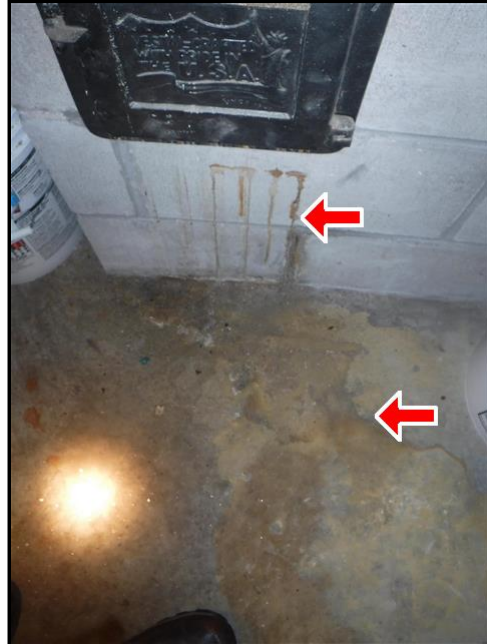
Found mortar missing and top of chimney in need of a full coverage rain cap. Item 1(Picture) Item 2(Picture)

Recommend having a chimney repair contractor review and repair the chimney.

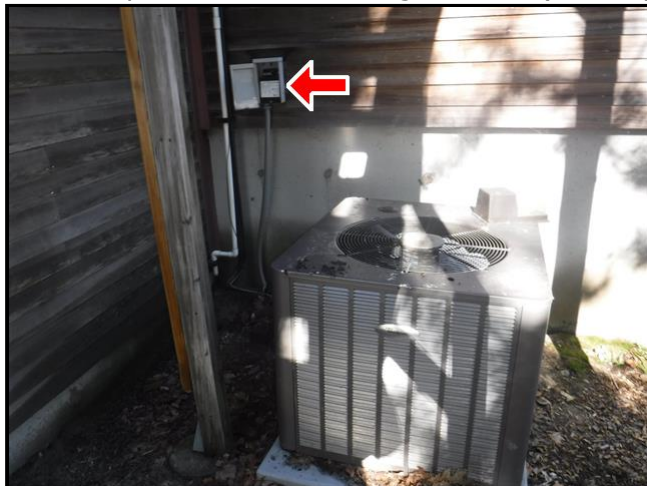
7.9 Item 1(Picture)

Found the main shut off breaker cover open to the elements outside by the cooler compressor. Keep closed to prevent water damage. Item 1(Picture)

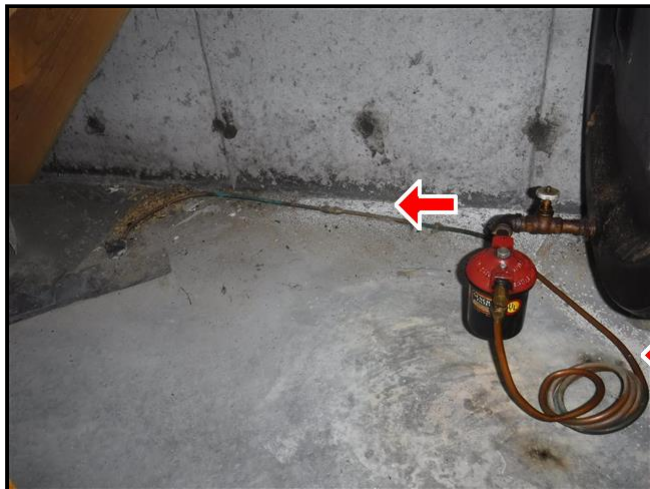
7.12 Item 1(Picture)

Tanks should not be built in to a concealed space to access for service. Have the entire fuel line installed in a protective conduit to prevent damage and corrosion. Item 1(Picture)

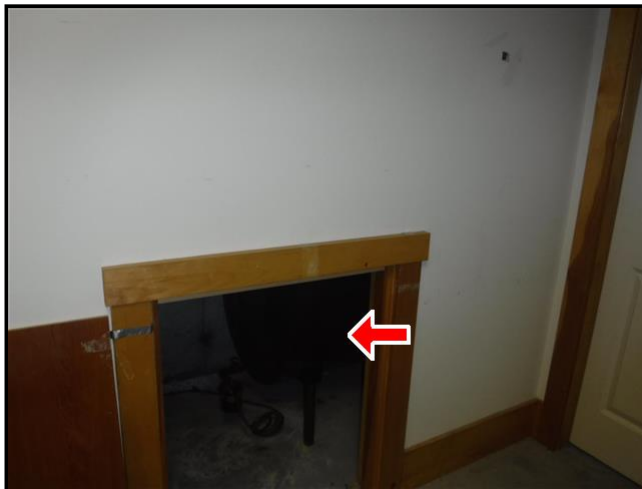
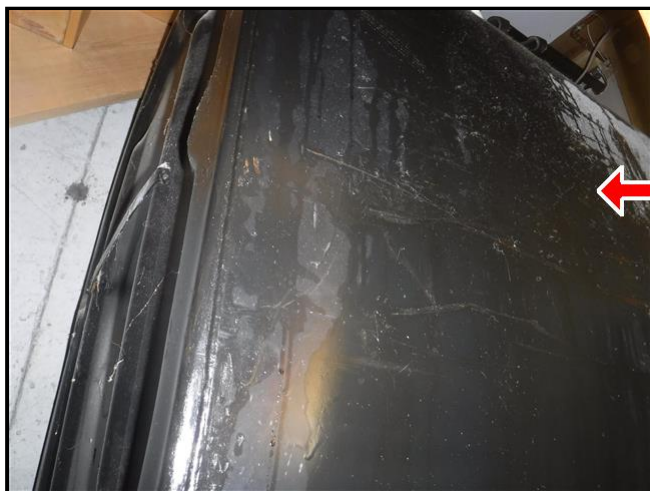
Found oil on the tank that may leak during filling. Leaks appear to be coming from the fill pipe. Item 2(Picture) Item 3(Picture)

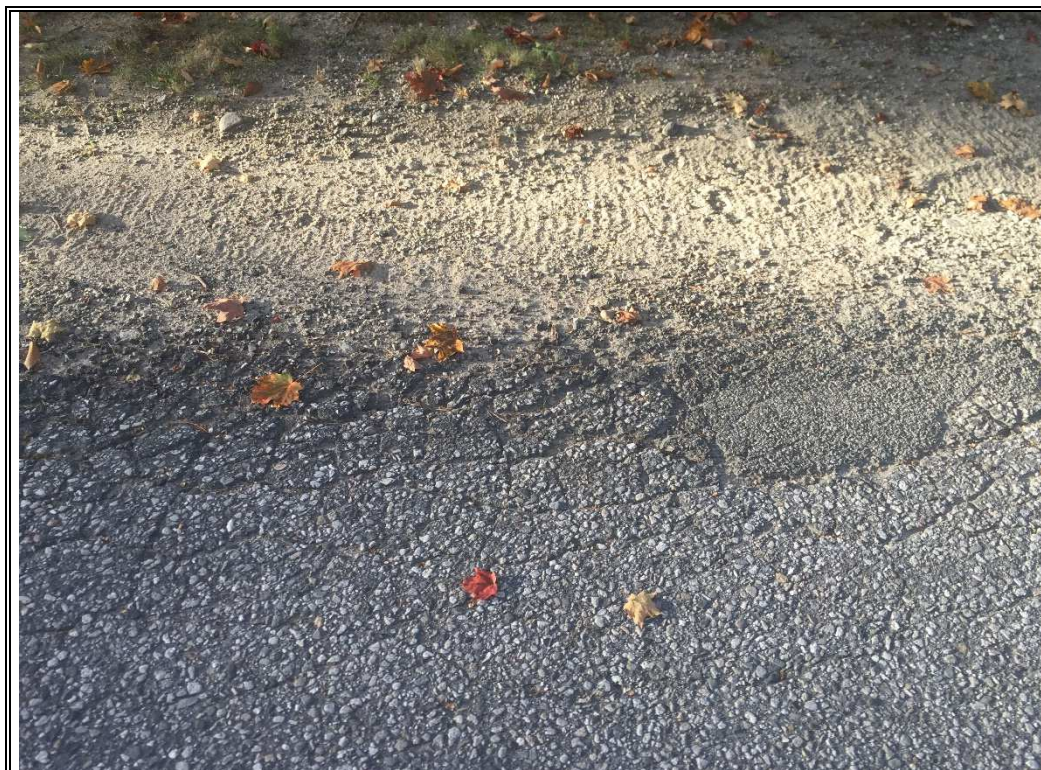
3

Pavement is
weathered and
cracked

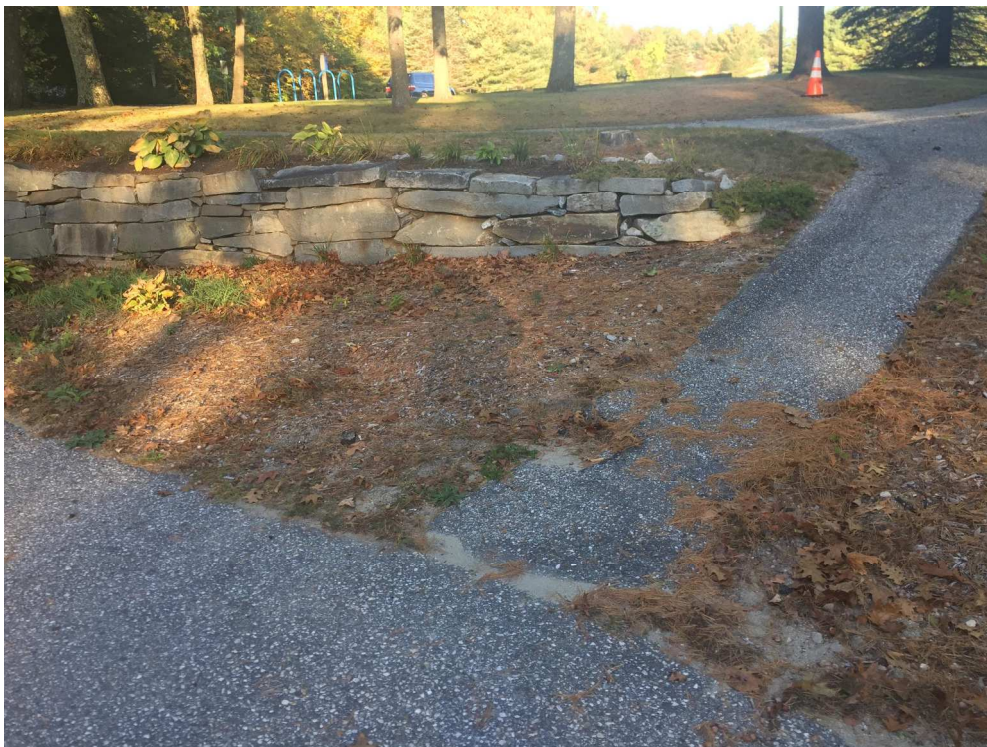
9

Stone retaining walls maintain grade separation between building exposures. Asphalt around the building are weathered and cracked.

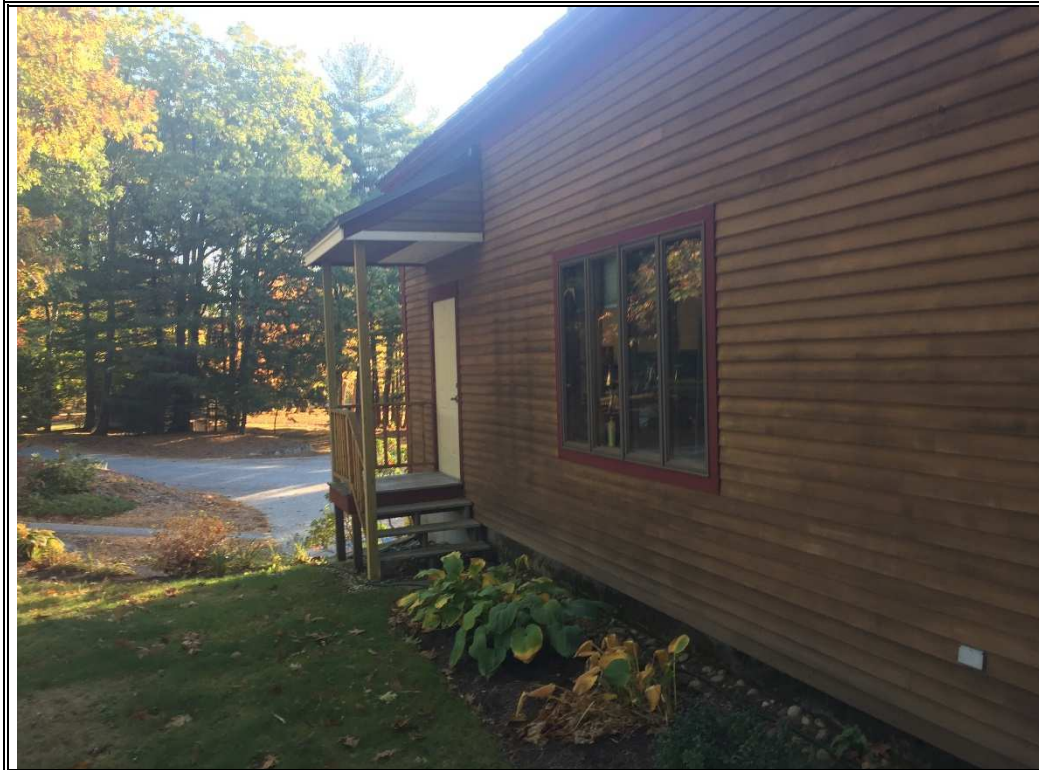
Recently replaced siding on the north wall and newly framed porch at staff office egress door

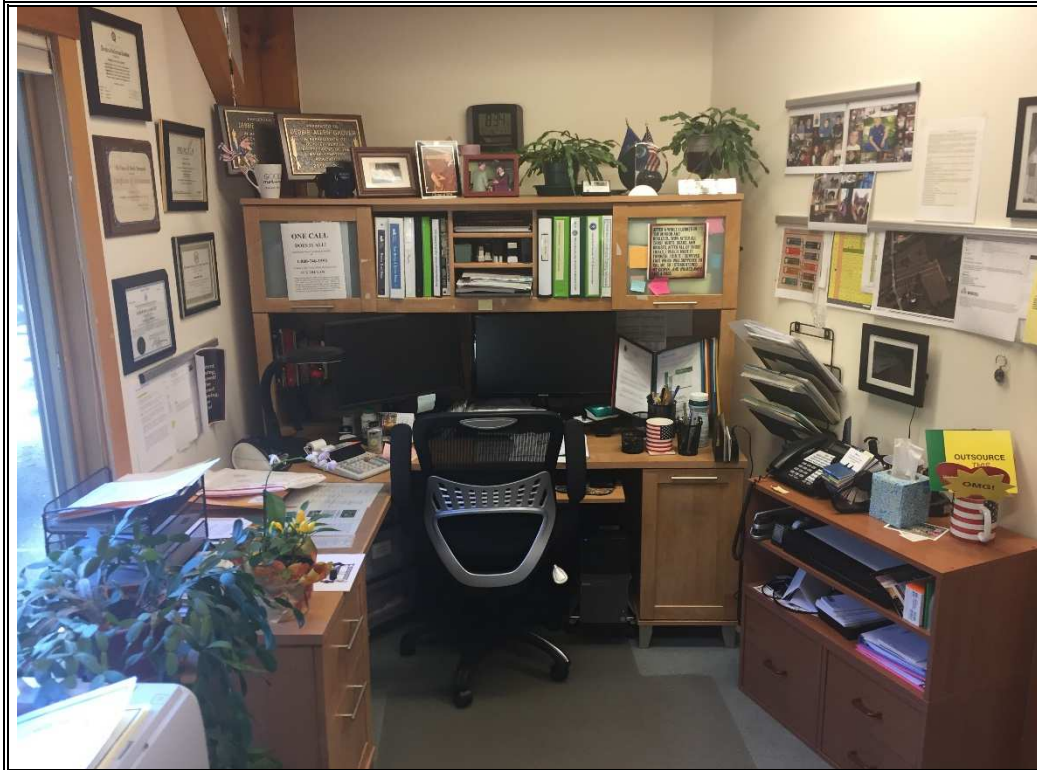
Upper floor back offices. Floor framing below is not completely level in this area.

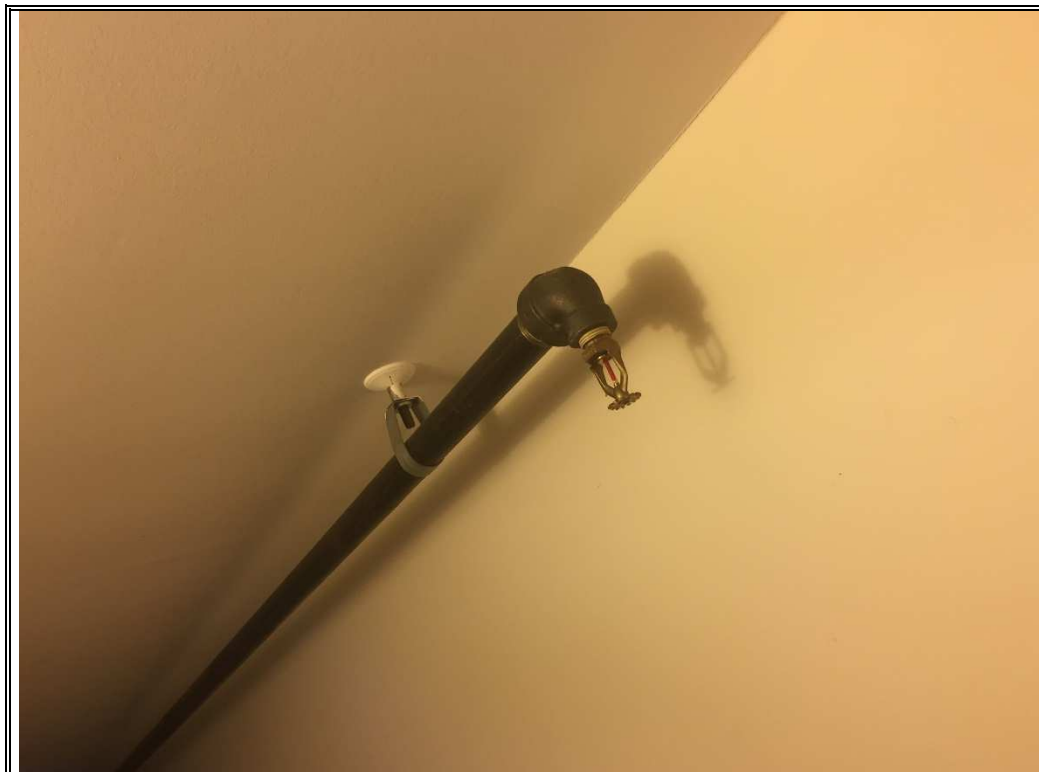
Entire building has been retrofitted with an automatic fire protection sprinkler system

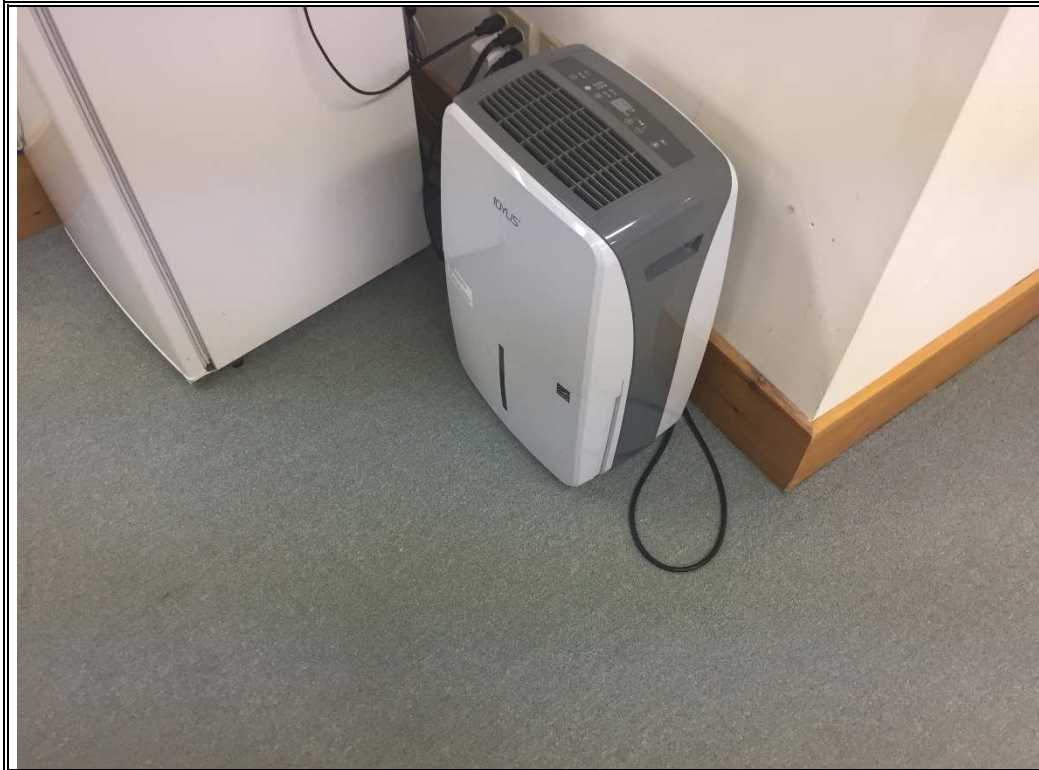
Mechanical

Basement
dehumidifier

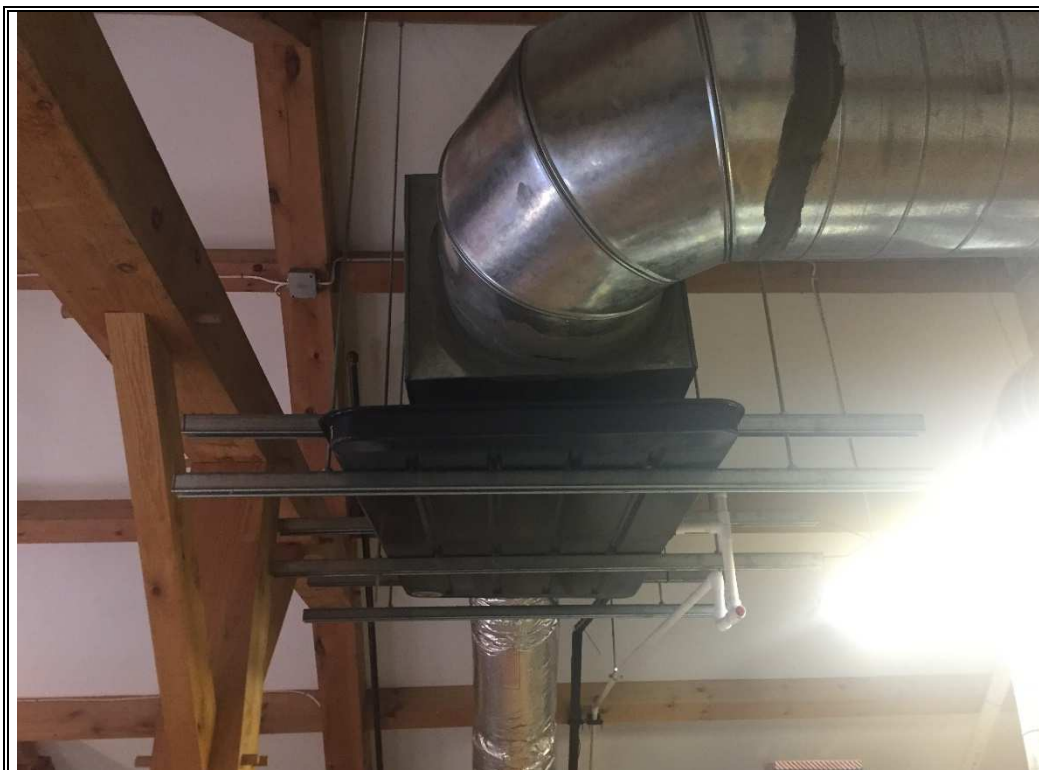
43

Mechanical

Attic air
conditioning air
handler is
inefficient.
Uninsulated
ductwork is noisy.

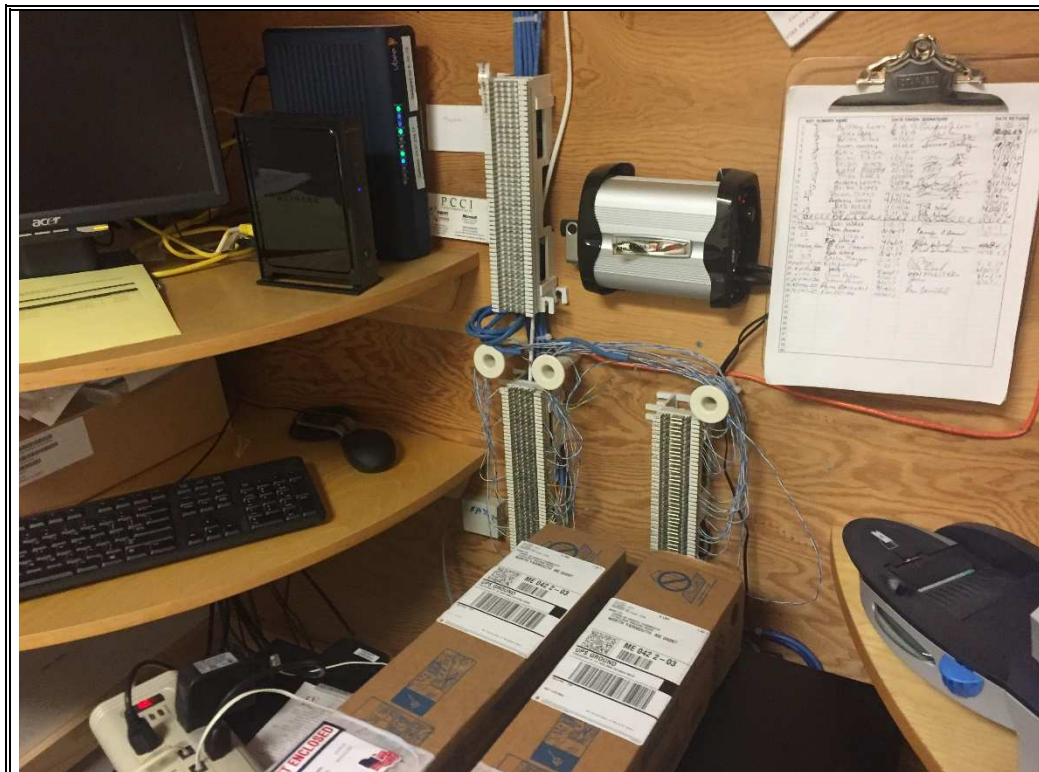
Mechanical
Telephone wiring

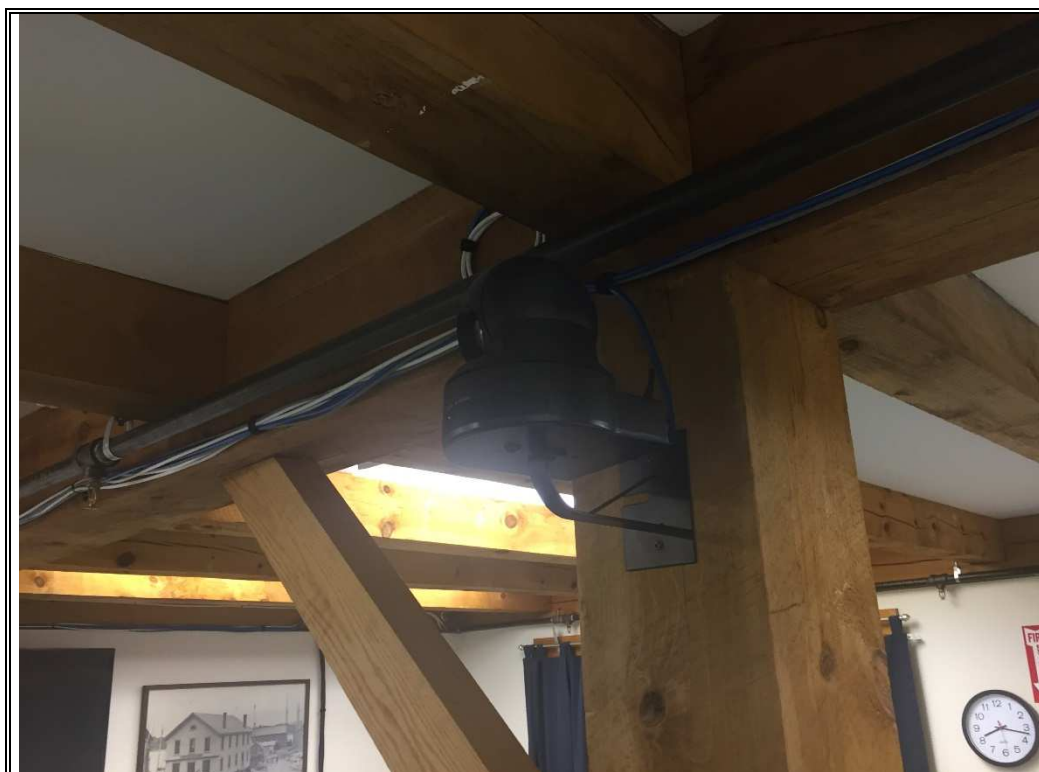
Photo Number
47

Mechanical
Public access
television system
in Meeting Room
